FACILITY CONDITION ASSESSMENT

Town of Paradise Valley
6401 East Lincoln Drive
Paradise Valley, AZ 85253

Municipal Court
6517 East Lincoln Drive
Paradise Valley, AZ 85253

July 9, 2025

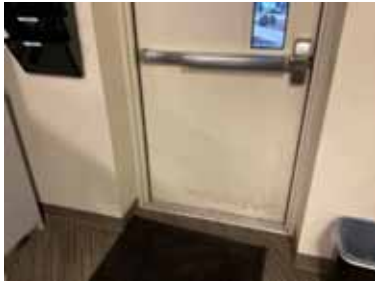
Exterior Door in Poor condition.

Wood, any type
007 - Municipal Court
Building Exterior

The inside of exterior steel doors are scuffed and discolored, need painting. - AssetCALC ID: 9391152

Uniformat Code: B2050
Recommendation: **Refinish in 2026**

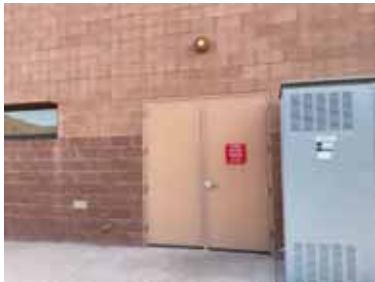
Exterior Light

any type, w/ LED Replacement
007 - Municipal Court
Fire Riser Room

Uniformat Code: D5040
Recommendation: **Replace in 2026**

Recommend light installed above fire riser room doors. - AssetCALC ID: 9391157
