# FACILITY CONDITION ASSESSMENT

**Town of Paradise Valley**  
6401 East Lincoln Drive  
Paradise Valley, AZ 85253  
Isaac Chavira

Town Hall  
6401 East Lincoln Drive  
Paradise Valley, AZ 85253

July 7, 2025

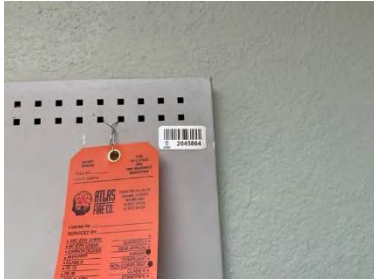
### Fire Alarm Panel in Failed condition.

Fully Addressable  
Town Hall  
Lobby

Aged and not communicating. - AssetCALC ID: 9387282

Uniformat Code: D7050  
Recommendation: **Replace in 2025**

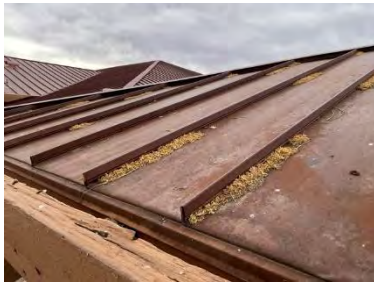
### Roofing in Poor condition.

Metal  
Town Hall  
Roof

Rusted metal - AssetCALC ID: 9387301

Uniformat Code: B3010  
Recommendation: **Replace in 2027**

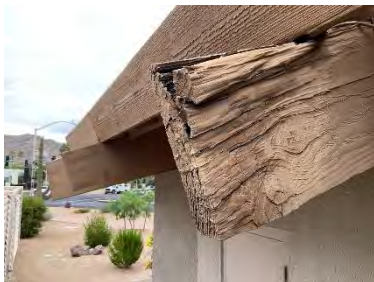
### Exterior Walls in Poor condition.

any type, Repairs per Man-Day  
Town Hall  
Building Exterior

Dry rotted fascia boards and rafters' tails - AssetCALC ID: 9387329

Uniformat Code: B2010  
Recommendation: **Repair in 2027**

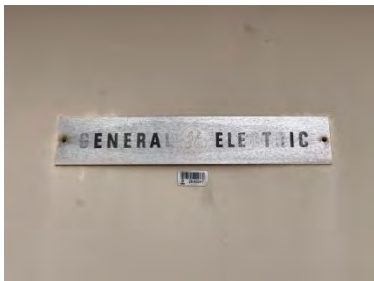
### Switchboard in Poor condition.

277/480 V  
Town Hall  
Chiller Yard

Broken handle will not open. - AssetCALC ID: 9387348

Uniformat Code: D5020  
Recommendation: **Replace in 2025**

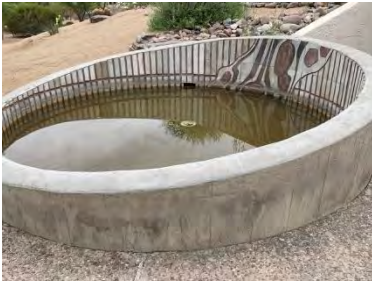
### Decorative Fountains in Failed condition.

Aerator or Nozzle, 1 HP  
Town Hall  
Site

Non-functional fountain with stagnant, standing water. - AssetCALC ID: 9387288

Uniformat Code: G2060  
Recommendation: **Replace in 2025**

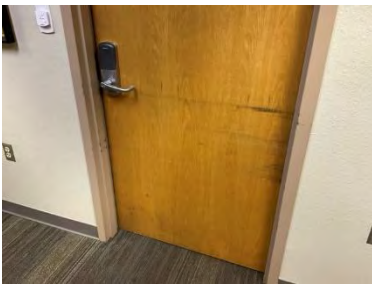
### Exterior Door in Poor condition.

Wood, any type  
Town Hall  
Post Office

Uniformat Code: B2050  
Recommendation: **Refinish in 2026**
