# FACILITY CONDITION ASSESSMENT

**Town of Paradise Valley**  
6401 East Lincoln Drive  
Paradise Valley, AZ 85253  
Isaac Chavira

Police Department  
6433 East Lincoln Drive  
Paradise Valley, AZ 85253

July 8, 2025

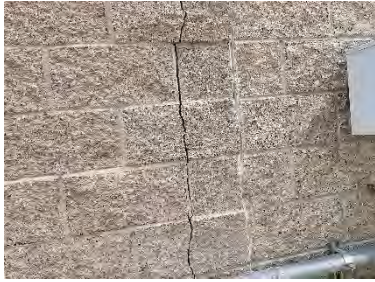
### Exterior Walls in Poor condition.

Concrete Block (CMU)  
Police Department  
Southeast Corner

CMU is cracked vertically due to settling. Repair as needed to prevent water infiltration. - AssetCALC ID: 9398019

Uniformat Code: B2010  
Recommendation: **Repair in 2025**

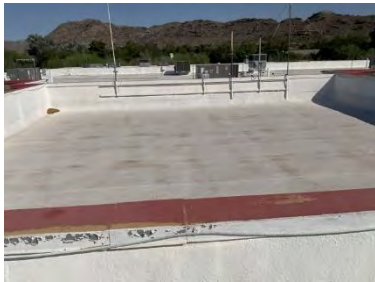
### Roofing in Poor condition.

Built-Up  
Police Department  
Roof

Brittle bubbles observed in places. 10 year warranty expired in 2024 per POC. Recommend complete replacement to maintain building integrity. - AssetCALC ID: 9398034

Uniformat Code: B3010  
Recommendation: **Replace in 2027**

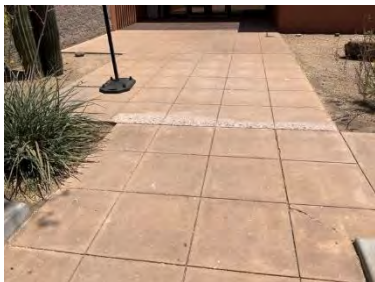
### Sidewalk in Poor condition.

Brick/Masonry Pavers  
Police Department  
Site

Pavers are heaved and uneven with gaps present. Repairs have been made to minimize trip hazards. Recommend reinstalling or replacing pavers as needed. - AssetCALC ID: 9398038

Uniformat Code: G2030  
Recommendation: **Replace in 2026**

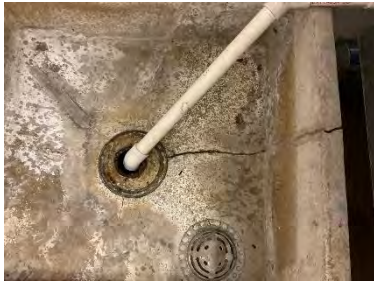
**Sink/Lavatory in Poor condition.**

Service Sink, Floor  
Police Department  
PS-123

Cracked basin - AssetCALC ID: 9398074

Uniformat Code: D2010  
Recommendation: **Replace in 2026**

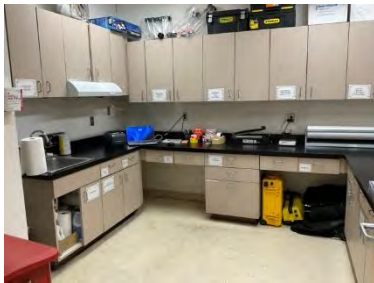
**Casework in Poor condition.**

Cabinetry, Standard  
Police Department  
Breakroom

Worn and damaged casework. - AssetCALC ID: 9398078

Uniformat Code: E2010  
Recommendation: **Replace in 2027**

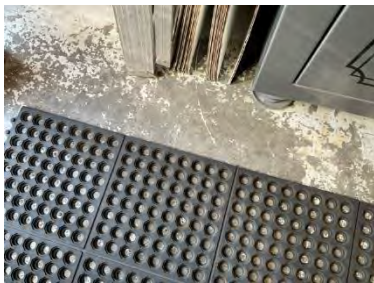
**Flooring in Poor condition.**

any surface, with Paint or Sealant  
Police Department  
Armory

Peeling paint - AssetCALC ID: 9397987

Uniformat Code: C2030  
Recommendation: **Prep and Paint in 2026**
