# FACILITY CONDITION ASSESSMENT

**Town of Paradise Valley**  
6401 East Lincoln Drive  
Paradise Valley, AZ 85253

Fire Station 91  
8444 North Tatum Boulevard  
Paradise Valley, AZ 85253

July 8, 2025

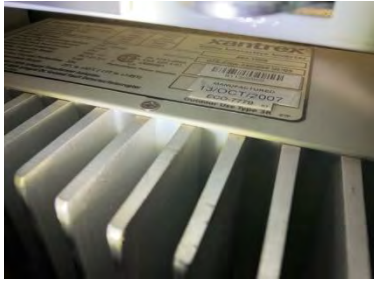
### Solar Power in Failed condition.

Inverter, 2.8 KW  
Fire Station 91  
Electrical Room

Non-functional. OOC 3-4 years. - AssetCALC ID: 9407858

Uniformat Code: D5010  
Recommendation: **Replace in 2025**

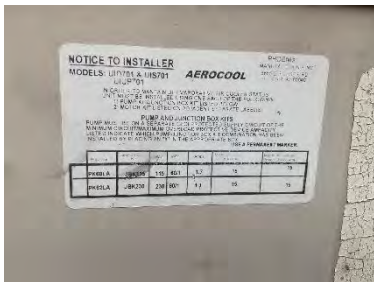
### Evaporative Cooler in Poor condition.

2 to 3 HP  
Fire Station 91  
Site Utility Areas

Actively leaking - AssetCALC ID: 9407870

Uniformat Code: D3030  
Recommendation: **Replace in 2026**
