# ROCK CUT SLOPE STABILITY ANALYSIS

PROPOSED CUSTOM HILLSIDE RESIDENCE

7550 NORTH HUMMINGBIRD LANE  
PARADISE VALLEY, ARIZONA 85253

Project 25998

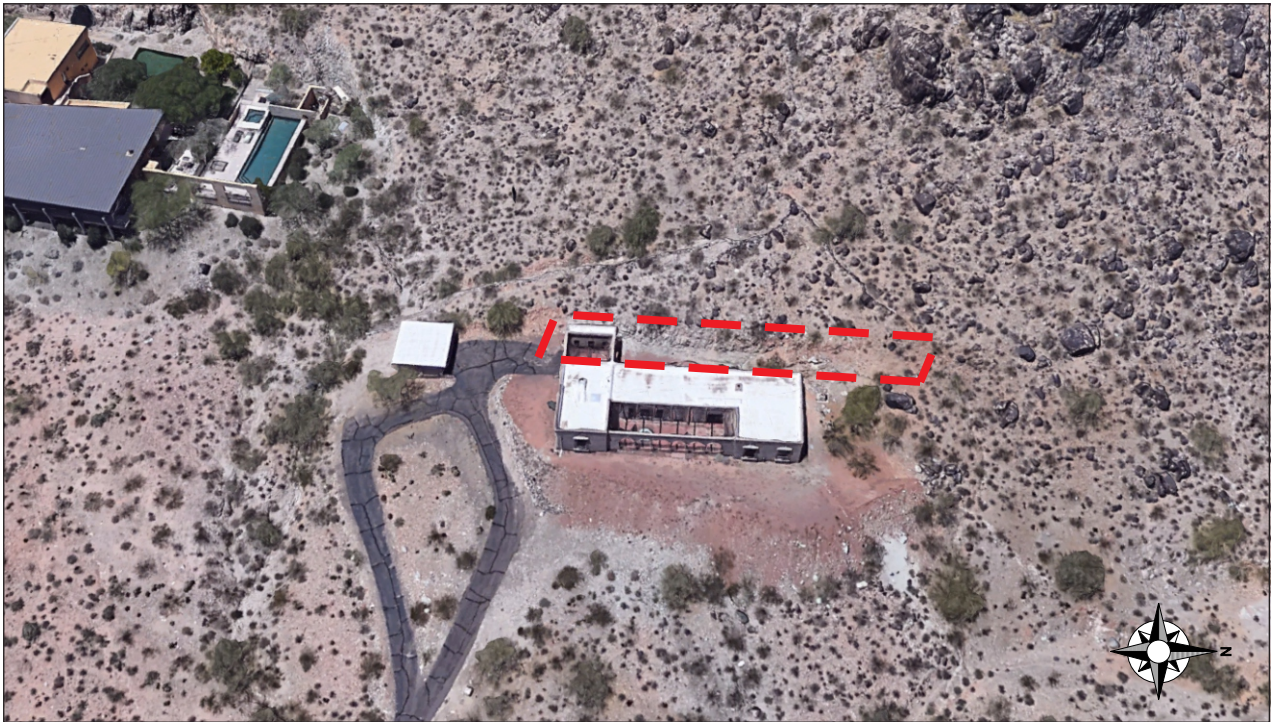
OBLIQUE AERIAL PHOTOGRAPH OF THE SITE, SHOWING THE CURRENT SITE CONDITIONS. THE EXISTING CUT SLOPE IS LOCATED ALONG THE WEST SIDE OF THE SITE SHOWN IN THE AERIAL PHOTOGRAPH (OUTLINED IN RED).

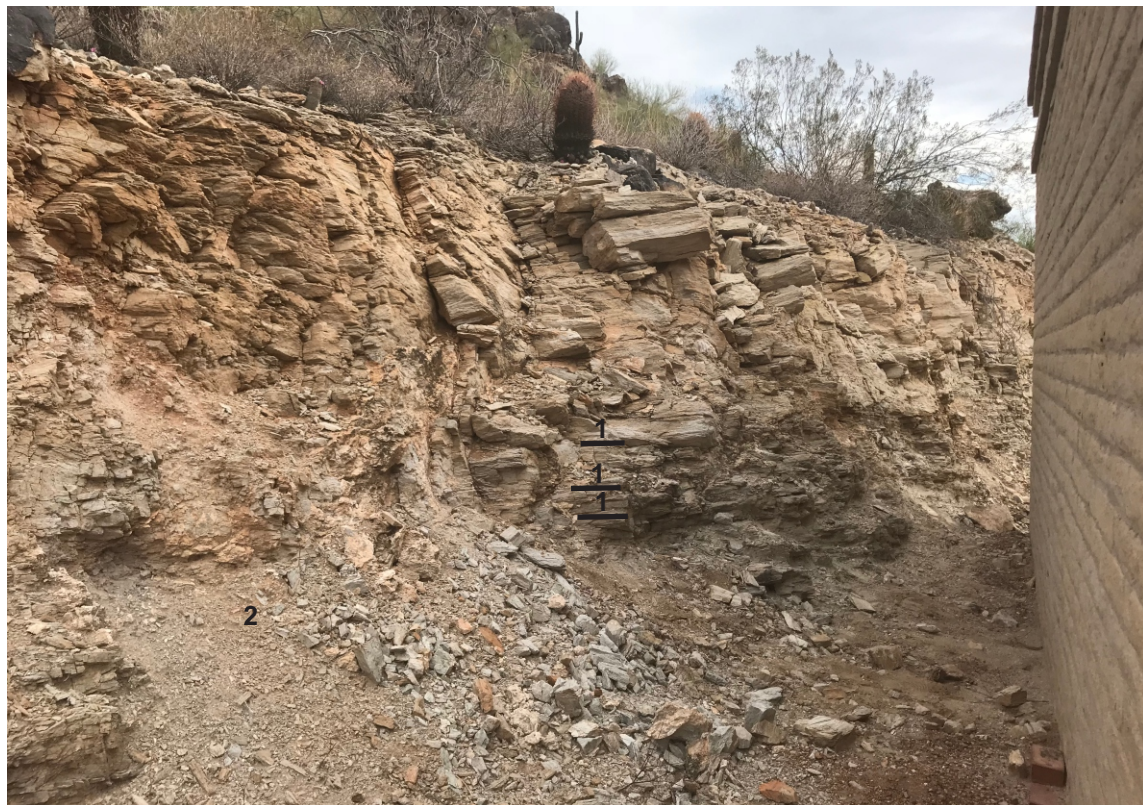
FACING NORTH

1) FOLIATION OF CUT SLOPE

2) HEAVILY BROKEN ROCK MASS

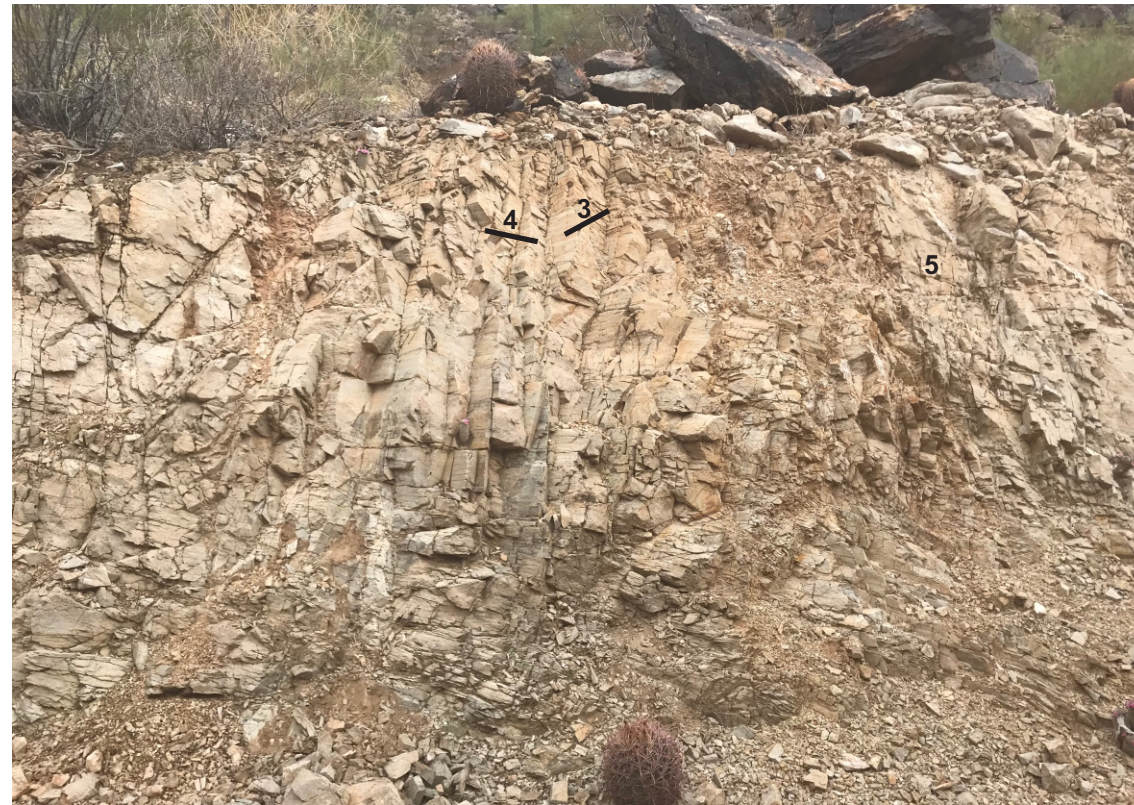
FACING WEST

3) CONJUGATE FRACTURE SET 1  
4) CONJUGATE FRACTURE SET 2

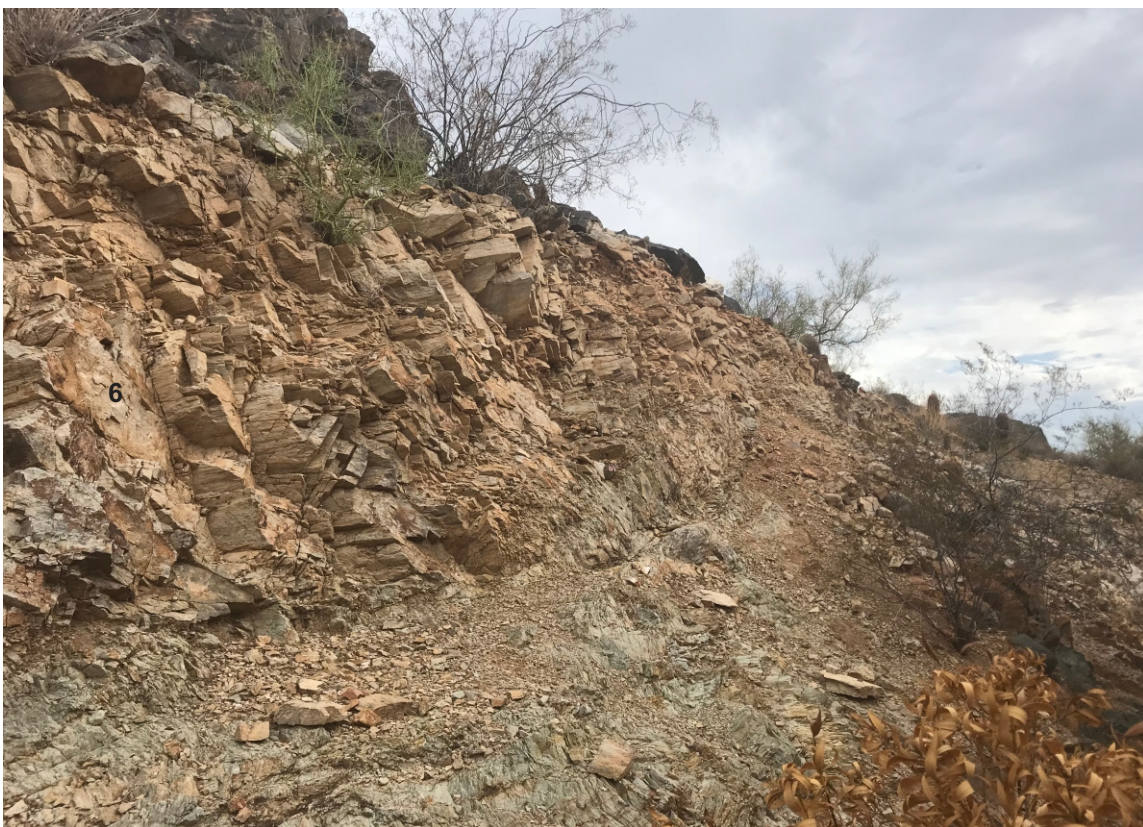
FACING NORTH

5) APPROXIMATE SLOPE ANGLE OF 80 DEGREES

6) APPROXIMATE SLOPE ANGLE OF 65 DEGREES

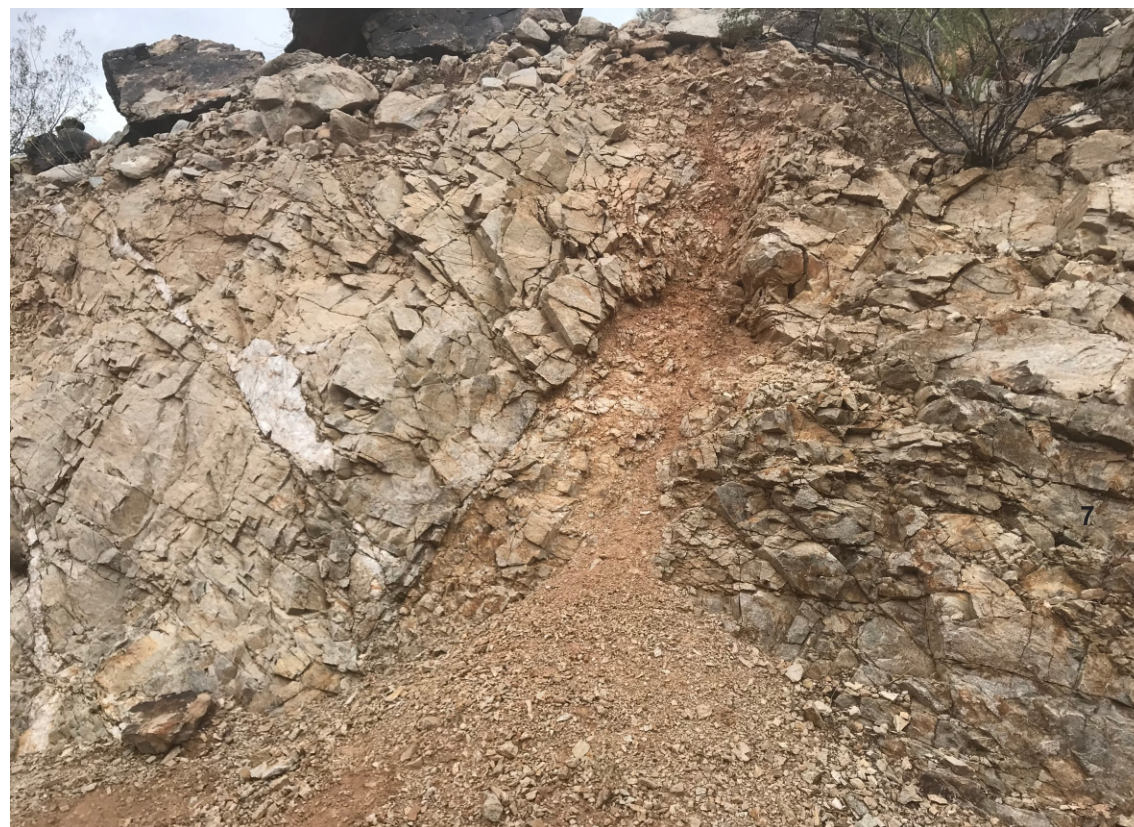
FACING WEST

7) APPROXIMATE SLOPE ANGLE OF 65 DEGREES

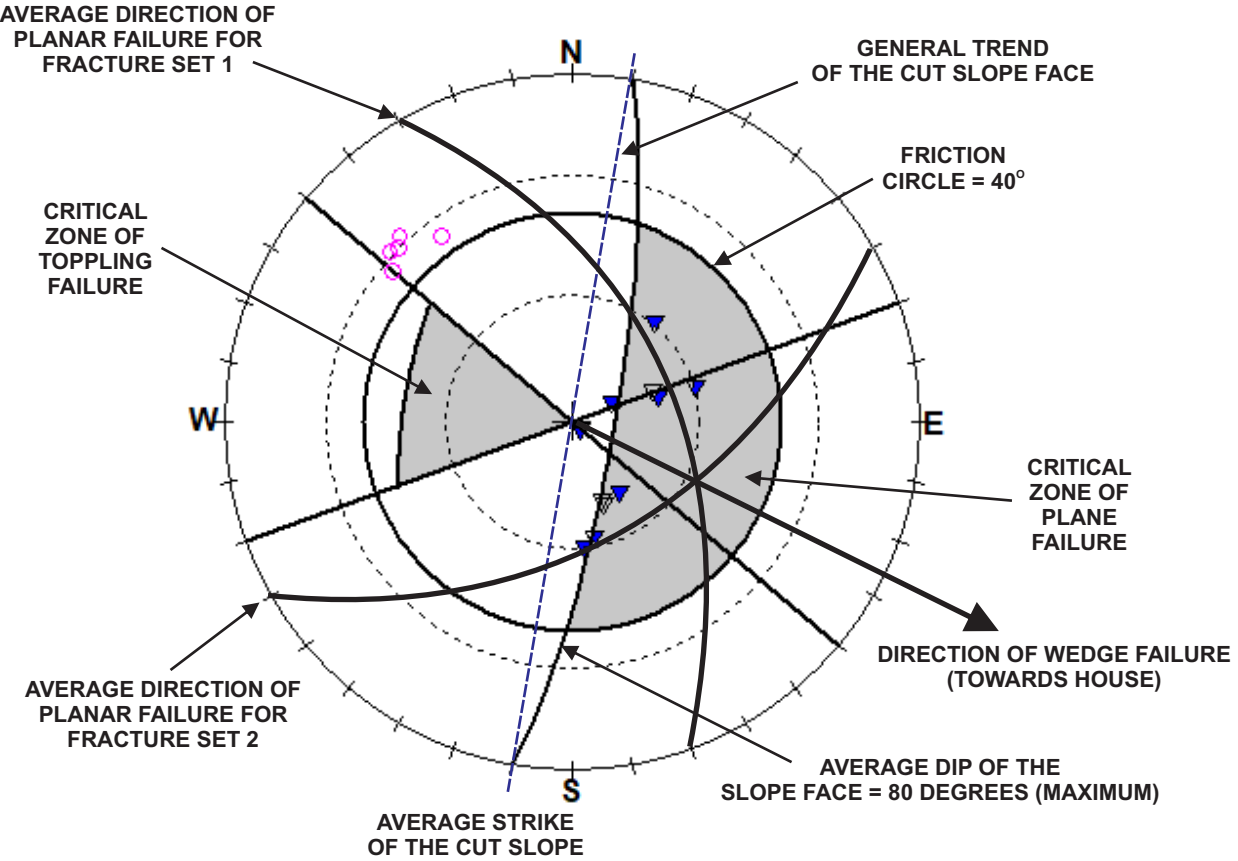
THE IMAGE ABOVE IS A STERONEUT AND IS USED FOR KINEMATIC STABILITY ANALYSIS. STEREOGRAPHIC PROJECTION INVOLVES PLOTTING 3D DATA (FOLIATION, BEDDING, AND FRACTURES) ON TO A 2D SURFACE WHERE IT CAN BE MANIPULATED AND INTERPRETED. FOR THIS STUDY, OPEN PINK CIRCLES REPRESENT FOLIATION OF THE CUT SLOPE WHILE BLUE TRIANGLES REPRESENT FRACTURES. STERONEUTS ARE PARTICULAR USEFUL IN THE GEOTECHINICAL REALM BECAUSE THEY CAN PROJECT POSSIBLE MOVEMENT OR FAILURES (PLANAR, WEDGE, OR TOPPLE) OF THE COLLECTED FIELD DATA. FROM OUR DATA WE CAN SEE THAT THERE IS LITTLE RISK OF TOPPLE FAILURE, REPRESENTED BY NO DATA

THE MAIN CUT IS LOCATED ON THE WESTERN EDGE OF THE SITE. THE ROCKS ASSOCIATED WITH THIS CUT SLOPE ARE PREDOMINANTLY QUARTZ-MUSCOVITE-SCHIST THAT CONTAIN DIFFERENT MAGNITUDES OF FOLIATION. QUARTZ VEINS AND A MAFIC INTRUSION ARE ALSO PRESENT. THE MOST PREDOMINANT DISCONTINUITY ALONG THE WESTERN AND EASTERN 1/3 OF THE SLOPE IS FOLIATION, AND THE MOST COMMON DISCONTINUITIES ALONG THE CENTRAL

The remediation of the existing cut slope will ensure the structural integrity to remain intact well into the future. It is needed because the visual observations along with the structural data presented in the markland stability analysis show a probability of both planar and wedge failure. The remediation of the existing cut slope will not completely prevent future surface erosion or the possibility of small rock fragments from falling off of the face of the cut slope. If the client desires shotcrete and faux rock, can be used to cover the exposed face of the cut slope and minizmie possibility of detritus falling from the slope.
