***BOULDER STABILITY EVALUATION***

***PROPOSED CUSTOM HILLSIDE RESIDENCE***

***July 30, 2018***

***Project 25998***

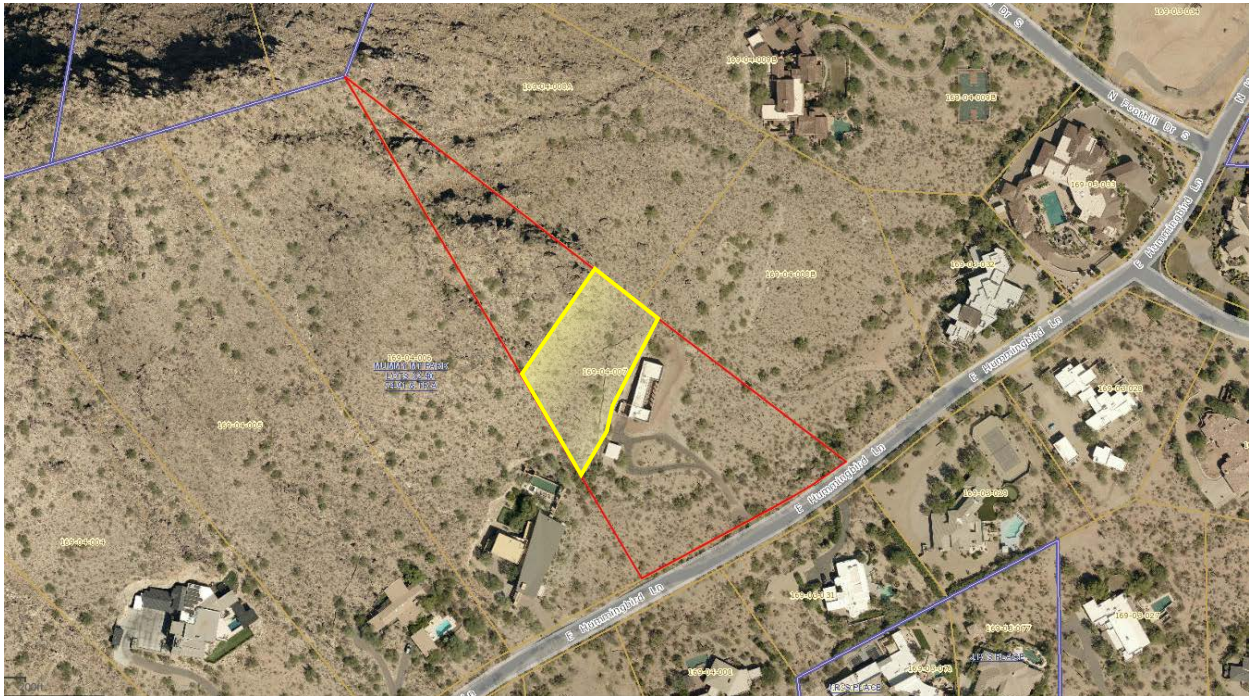
**Figure 1: Aerial photograph of site (outlined in red) and general location of the precariously balanced rocks (outlined in yellow)**

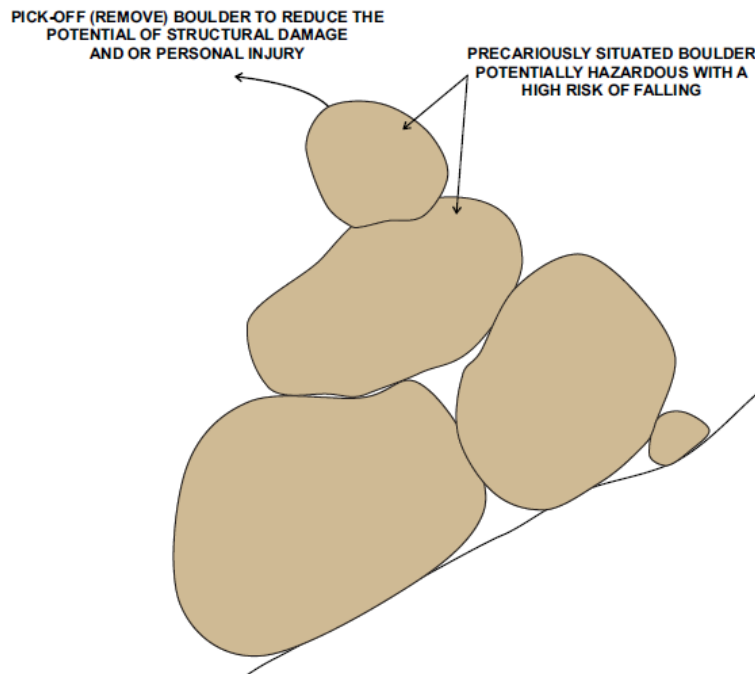
**Figure 2: Boulder pick-off illustration**

Furthermore, any smaller boulders or rock fragments (without a dimension greater than 3.0 feet) which sit atop other boulders should be removed, as depicted in the figure below. The stability of such boulders/rock fragments was not directly evaluated in this study; however, it is the opinion of this firm that such scenario presents a high potential for movement.

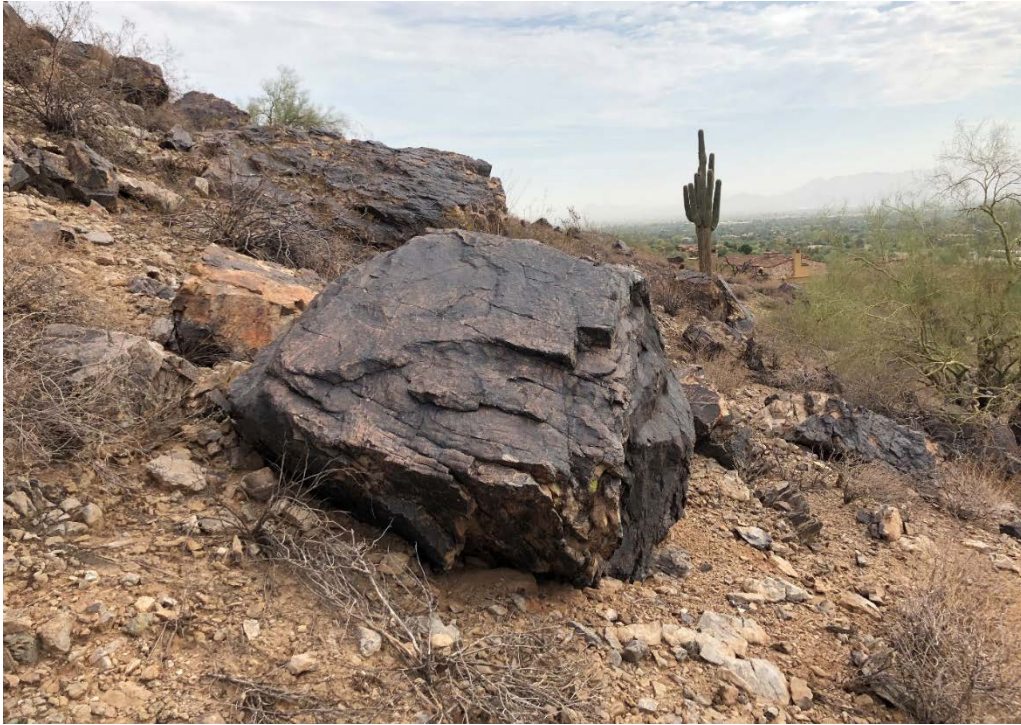
***B-1 (north facing)***

The analysis of the effects of potential erosion results in the FS and probability of downhill translation movement (sliding), for B-1, B-2, B-5, B-6, B-7, B-8, B-9, B-11, and B-13, which do not meet the design criteria.

The voids between the boulders (B-1, B-2, B-5, B-6, B-7, B-8, B-9, B-11, and B-13). and the underlying slope/pedestal should be filled with 4000 psi non-shrink grout (ASTM C1107). Any smaller boulders wedged between the subject boulders and the underlying rock mass should be encompassed within the grout as well. On the downhill side of the boulder, the top soil should be removed so that the grout makes clean contact with the underlying rock. The grout should be formed on the downhill side of the boulder to create a buttress. Refer to the Boulder Mitigation Protocol detail sheet in Section II of this report.

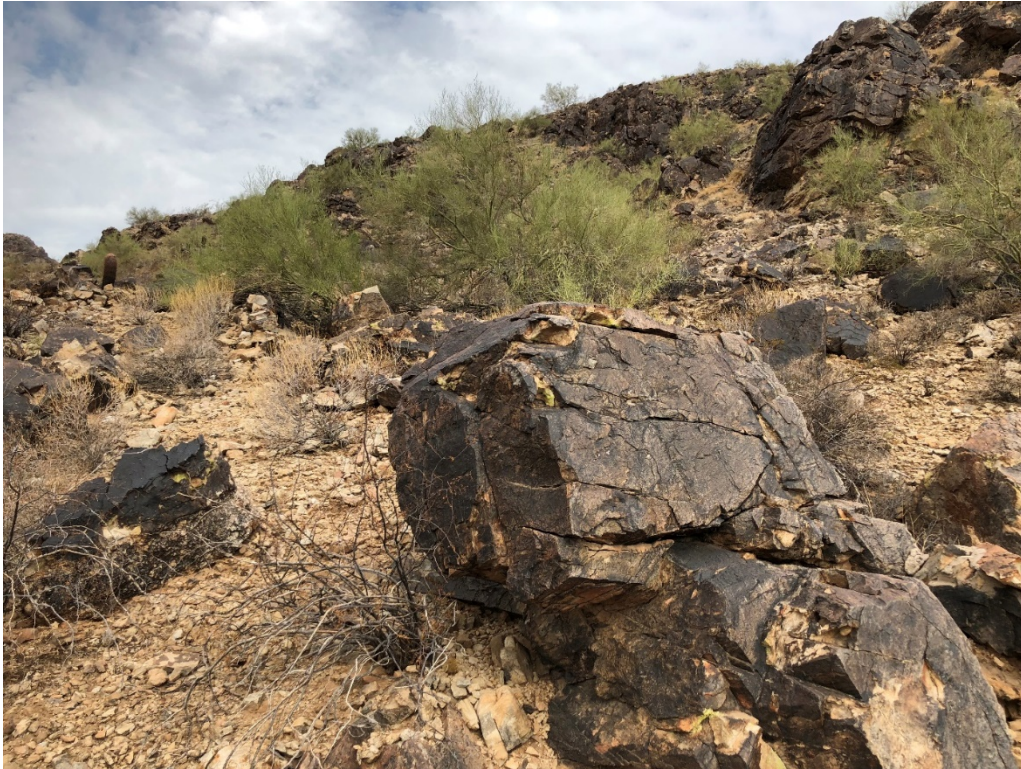
***B-5 (west facing)***

The analysis of the natural state of the boulder results in B-5, B-7, B-9, and B-11 not meeting the design criteria the factor of safety greater or equal to 1.5 and/or the probability of movement less than or equal to 10%.
