FACILITY CONDITION ASSESSMENT

Communications Building
6824 North Highlands Drive
Paradise Valley, AZ 85253

172662.25R000-008.468

July 9, 2025

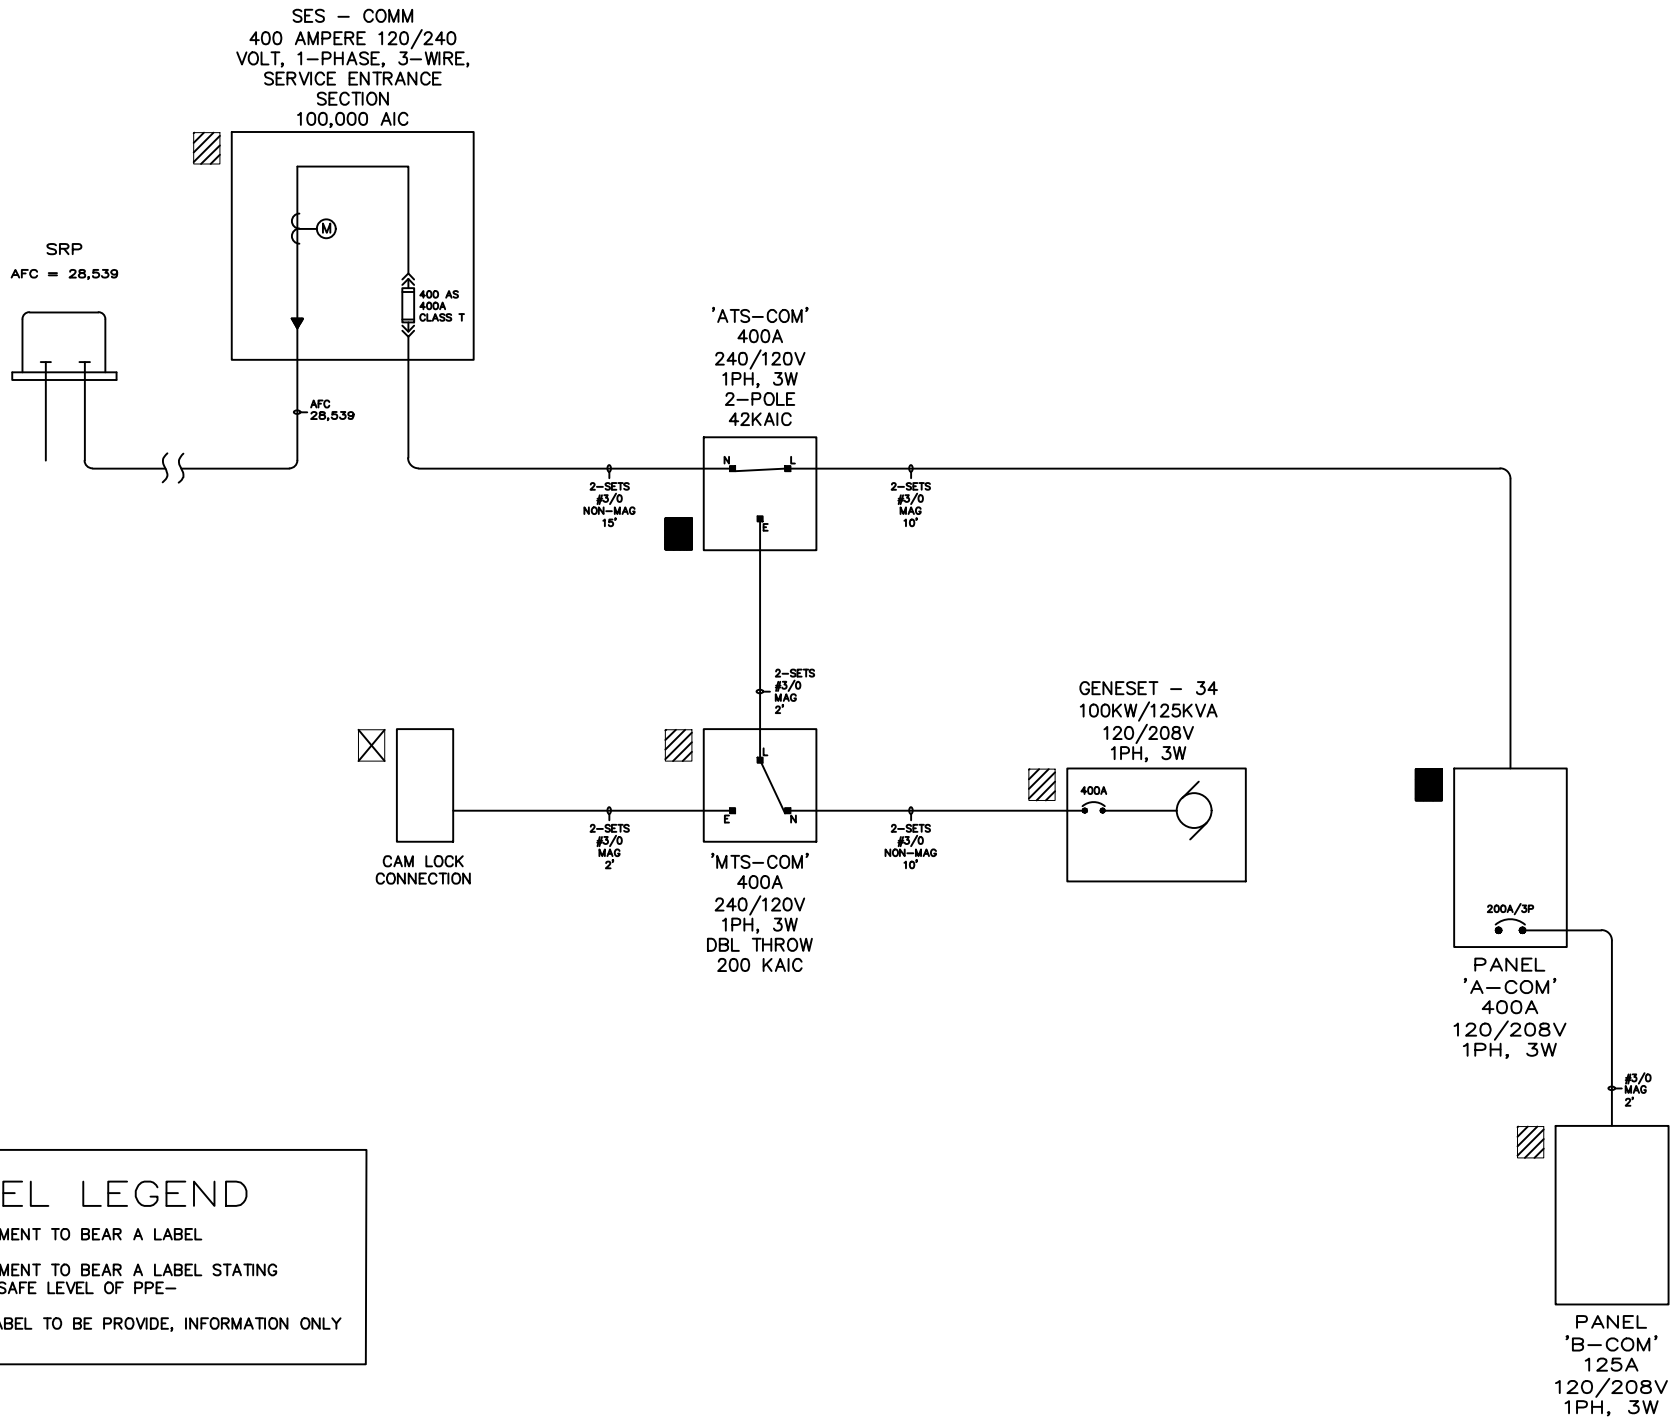
COMMUNICATIONS BUILDING

EQUIPMENT NAME:	ATS COM	VOLTAGE:	120/240	PHASE:	1Ø-3W	AMPS:	400	SCCR:	?	MAIN:	
EQUIPMENT TYPE:	AUTOMATIC XFR SW									MODEL:	
MANUFACTURER:	KOHLER									AMPS	
MODEL:	KSS-AFNA-0400S	OTHER COMMENTS									
TYPE:		SWITCH HAS MULTIPLE TERMINATIONS WHERE MORE THAN TWO CONDUCTORS									
FED FROM:		ARE TERMINATED. THIS IS A VIOLATION OF THE EQUIPMENT'S LISTING									
AFC:		AND CAN BE HAZARDOUS. THE TERMINATION WILL IMPACT THE WITHSTAND RATING OF THE EQUIPMENT.									
FEEDER SIZE:	2-SETS OF #3/0	A LABEL INDICATING THE EQUIPMENT'S WITHSTAND RATING WAS NOT IDENTIFIED.									
CONDUCTOR TYPE:	CU	A LABEL WILL BE PLACED INDICATING THERE IS NO SAFE LEVEL OF PPE.									
RACEWAY TYPE:	NON-MAG										
LENGTH:	15'										
MAIN:											
FEEDS		FRAME	SIZE	FUSE TYPE	AIC	CB MODEL	CB MAN	ADDITIONAL NOTES			
PANEL 'A-COM'

At the locations noted, the available fault current exceeds the AIC and/or SCCR ratings of the equipment. As documentation from the manufacturer was not available, it is not possible to verify if the equipment is permitted to be used as part of a series rated system. While it appears that the applications of the labels are correct, it should be independently verified.
