FACILITY CONDITION ASSESSMENT

EMT Ambulance Building
6517 East Lincoln Drive
Paradise Valley, AZ 85253

172662.25R000-001.468

July 7, 2025

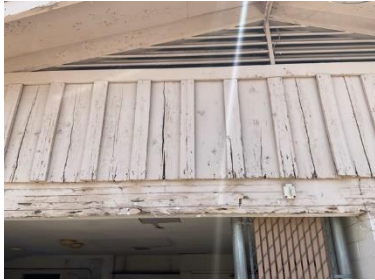
Exterior Walls in Poor condition.

Wood Siding
EMT Ambulance Building
Building Exterior

Degraded wood siding throughout - AssetCALC ID: 9384417

Uniformat Code: B2010
Recommendation: **Replace in 2027**

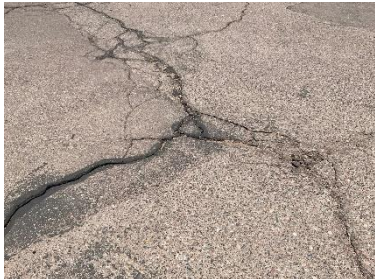
Parking Lots in Poor condition.

Pavement, Asphalt
EMT Ambulance Building
Site Parking Areas

Cracked due to excessive wear and tear. No designated striped parking spaces. - AssetCALC ID: 9384419

Uniformat Code: G2020
Recommendation: **Mill and Overlay in 2027**

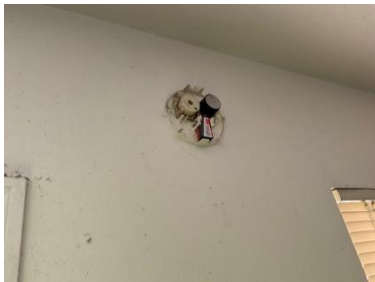
Fire Alarm Devices in Poor condition.

Smoke/Carbon Monoxide Detector, residential
by contractor
EMT Ambulance Building

Degraded smoke detector in kitchen - AssetCALC ID: 9401798

Location	UF Code	Description	Condition	Plan Type	Cost
EMT Ambulance Building	D7051	Fire Alarm Devices, Smoke/Carbon Monoxide Detector, residential by contractor, Replace	Poor	Performance/Integrity	\$200
TOTAL (1 items)					\$200

Uniformat Code: D7050
Recommendation: **Replace in 2025**

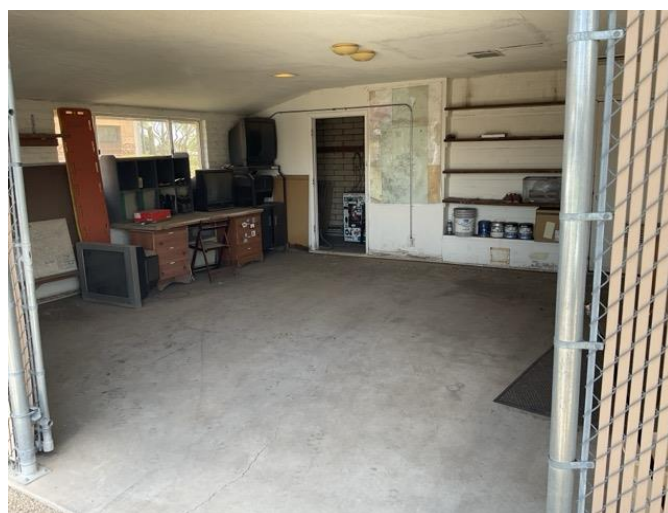
16 - CARPORT

The enclosed carport uses a chain link fence as its gate and contains the building's utility areas. The ancillary carport consists of metal posts and a canopy roof. The door to the carport storage room is missing. The carport ceiling has minor damage in need of repair.

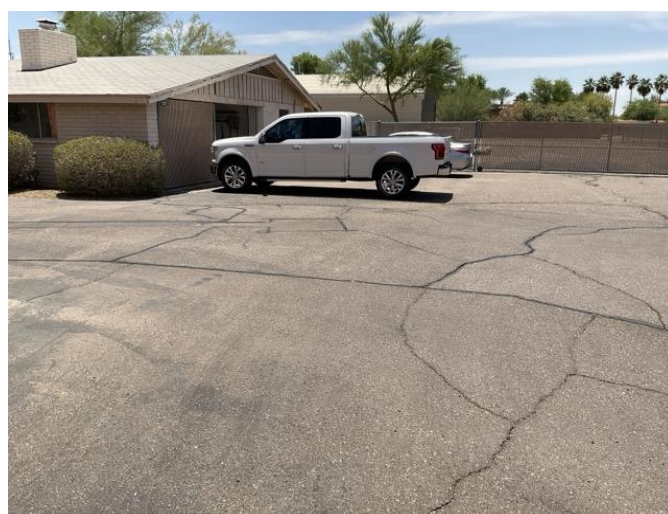
18 - PARKING LOT

The site is covered in stone and vegetative landscaping without irrigation and mature trees clustered in the front and backyard. There are numerous building-mounted incandescent light fixtures and one pole-mounted LED light fixture. The asphalt lot has large cracks due to excessive wear and tear.
