***BOULDER STABILITY EVALUATION***

***PROPOSED CUSTOM HILLSIDE RESIDENCE***

***7550 NORTH HUMMINGBIRD LANE***

***Project 25998***

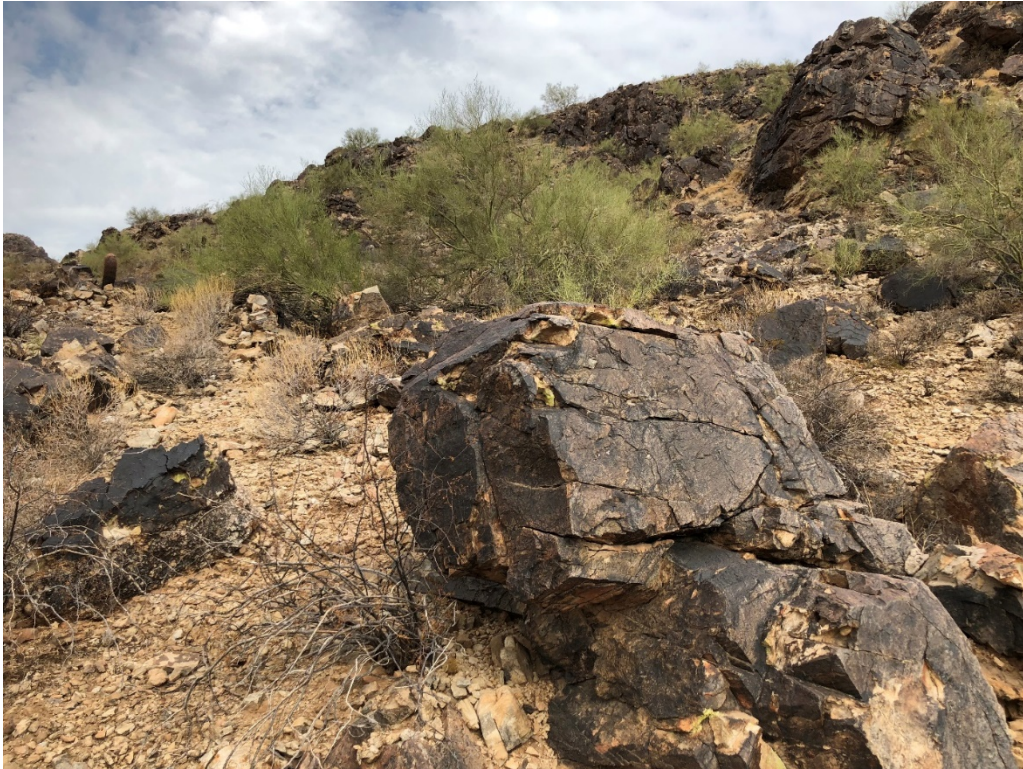
***B-5 (west facing)***

The analysis of the natural state of the boulder results in B-5, B-7, B-9, and B-11 not meeting the design criteria the factor of safety greater or equal to 1.5 and/or the probability of movement less than or equal to 10%.

The analysis of the effects of potential erosion results in the FS and probability of downhill translation movement (sliding), for B-1, B-2, B-5, B-6, B-7, B-8, B-9, B-11, and B-13, which do not meet the design criteria.

The voids between the boulders (B-1, B-2, B-5, B-6, B-7, B-8, B-9, B-11, and B-13). and the underlying slope/pedestal should be filled with 4000 psi non-shrink grout (ASTM C1107). Any smaller boulders wedged between the subject boulders and the underlying rock mass should be encompassed within the grout as well. On the downhill side of the boulder, the top soil should be removed so that the grout makes clean contact with the underlying rock. The grout should be formed on the downhill side of the boulder to create a buttress. Refer to the Boulder Mitigation Protocol detail sheet in Section II of this report.
