BOULDER STABILITY EVALUATION

***PROPOSED TONN RESIDENCE
APN 172-47-063
5429 EAST SOLANO DRIVE
PARADISE VALLEY, ARIZONA 85253***

September 27, 2018

Project 24215

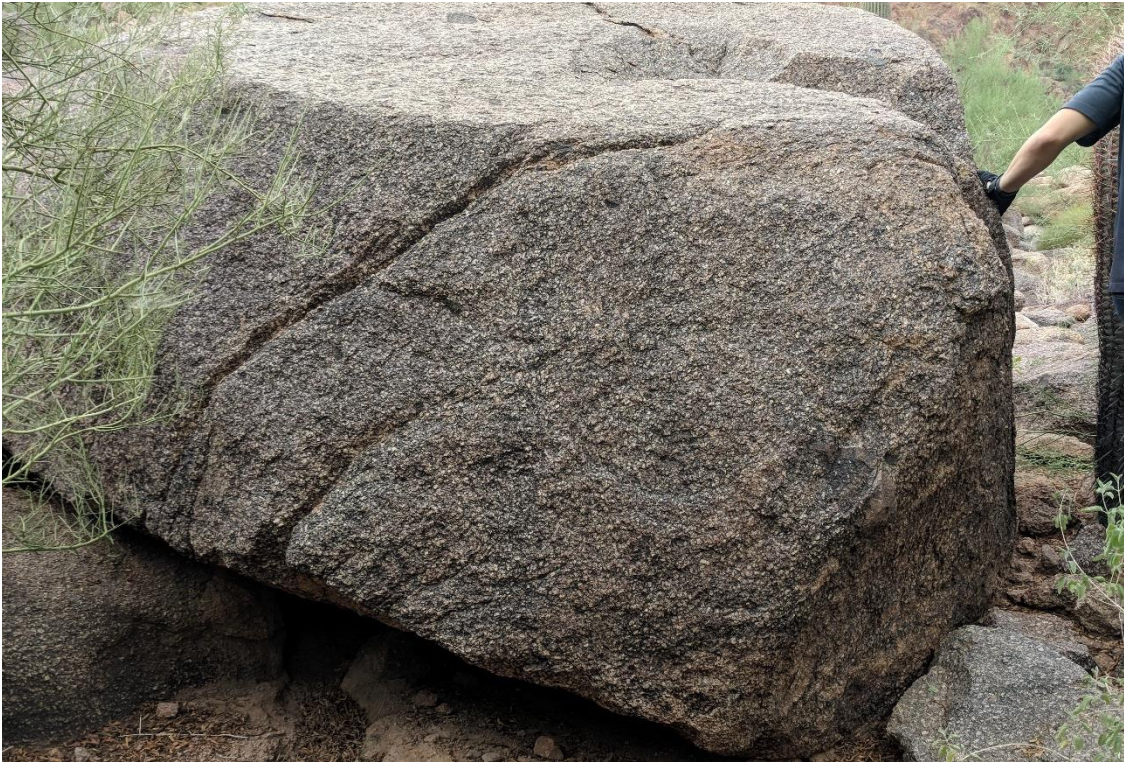
Figure 3: B-1 facing south

Boulder ID	FS	Probability of Movement
B-1	2.20	≤ 10%
B-2	1.28	28%
B-3	2.38	≤ 10%
B-4	1.62	≤ 10%
B-5	4.53	≤ 10%

Boulder ID	Sliding		Overturning	
	FS	Probability of Movement	FS	Probability of Movement
B-1	1.68	≤ 10%	13.62	≤ 10%
B-2	0.82	70	15.96	≤ 10%
B-3	1.65	≤ 10%	9.31	≤ 10%
B-4	1.35	≤ 10%	0.34	74
B-5	3.13	≤ 10%	4.90	≤ 10%

Boulder ID	FS	Probability of Movement
B-1	1.44	≤ 10%%
B-2	0.58	95%
B-3	1.24	34%
B-4	1.01	47%
B-5	2.23	≤ 10%

Boulder ID	In Situ	Seismic Shaking		Base Erosion	Stabilization Required
	(Sliding)	(Sliding)	(Toppling)	(Sliding)	
B-1	-	-	-	X	yes
B-2	X	X	-	X	yes
B-3	-	-	-	X	yes
B-4	-	-	X	X	yes
B-5	-	-	-	-	no

Boulder ID	BMP-2	BMP-7	BMP-8
B-1	X	-	-
B-2	X	-	X
B-3	X	-	-
B-4	X	X	-
B-5	-	-	-

The voids between the boulders (B-1, B-2, B-3, and B-4) and the underlying slope/pedestal should be filled with 4000 psi non-shrink grout (ASTM C1107). Any smaller boulders wedged between the subject boulders and the underlying rock mass should be encompassed within the grout as well. Grouting the interstitial spaces is referred to as BMP-2 in Section II of this report. Prior to grouting, the areas to be grouted should be power washed, and all loose rock fragments and vegetation should be removed.

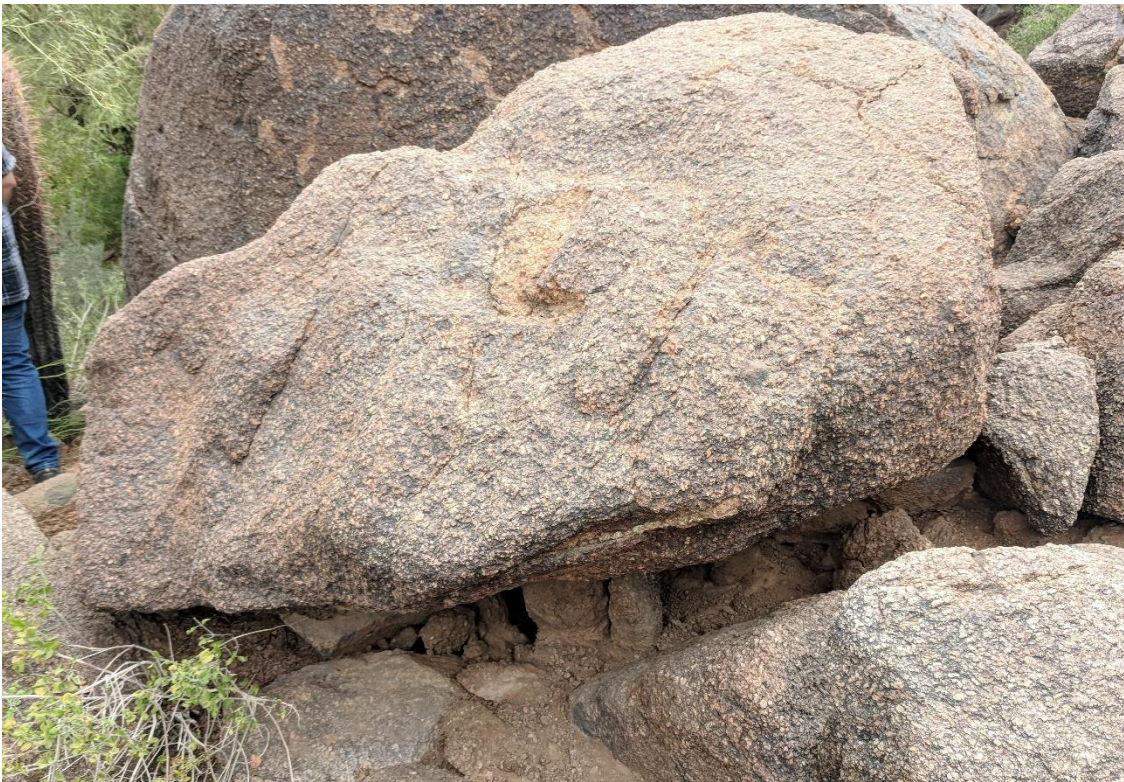
Figure 4: B-2 facing east

The analysis of the natural state of the boulder results in B-2 not meeting the design criteria the factor of safety greater or equal to 1.5 and/or the probability of movement less than or equal to 10%.

For boulders that require more sliding resistance in addition to that added by the interstitial grouting (B-2) The grout should be formed on the downhill side of the boulder to create a buttress. Refer to the BMP-8 in Section II of this report. The location of each boulder to be stabilized must be confirmed by this firm prior to grouting. Any smaller boulders wedged between the subject boulders and the underlying rock mass should be encompassed within the grout as well. The location of each boulder to be stabilized must be confirmed by this firm prior to grouting.

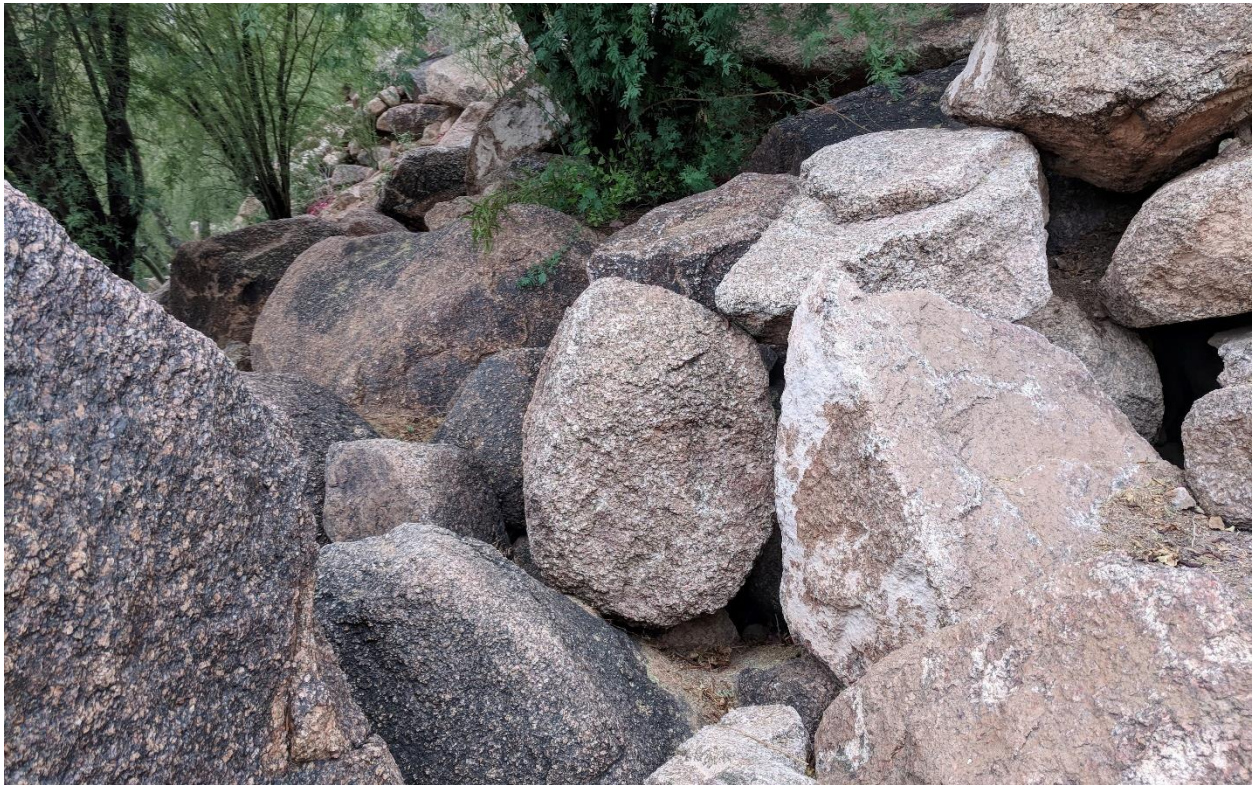
Figure 8: Photograph showing large boulder cluster surrounding Boulder #5

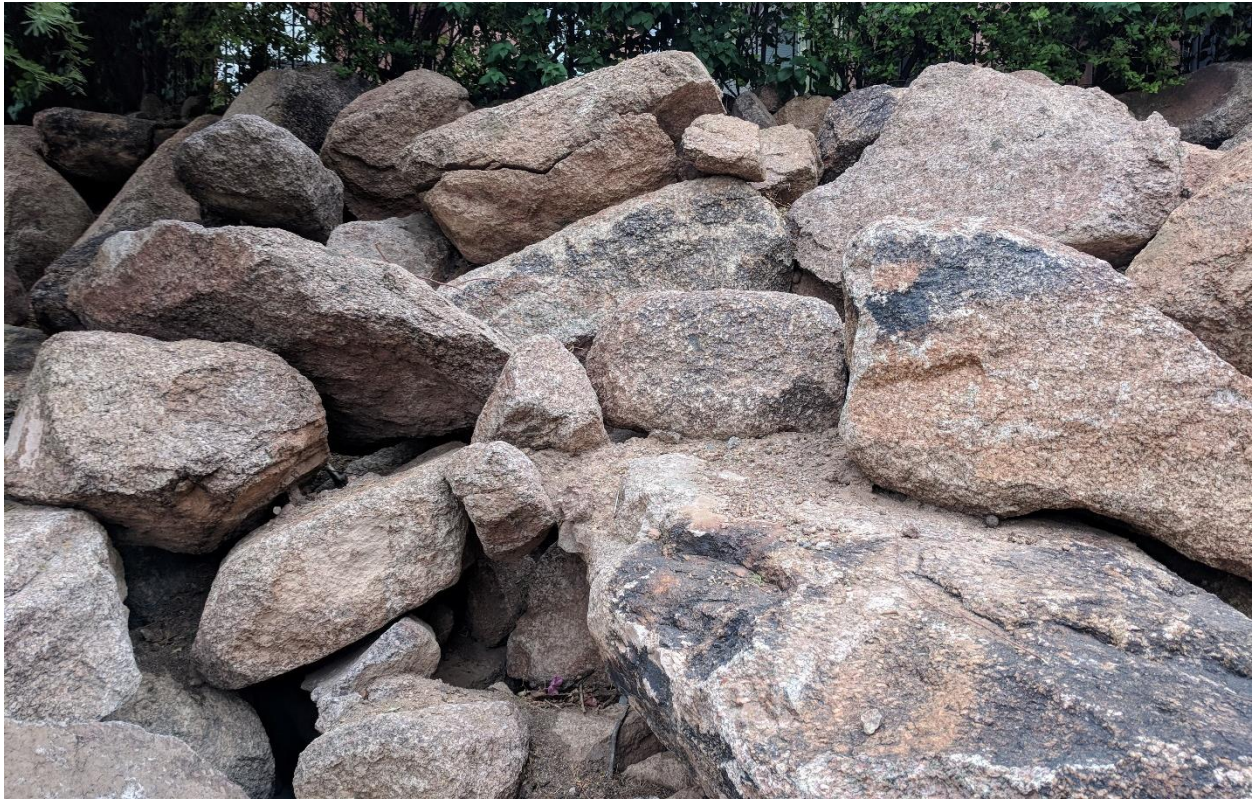
Figure 9: Photograph showing large boulder cluster near Boulder #5

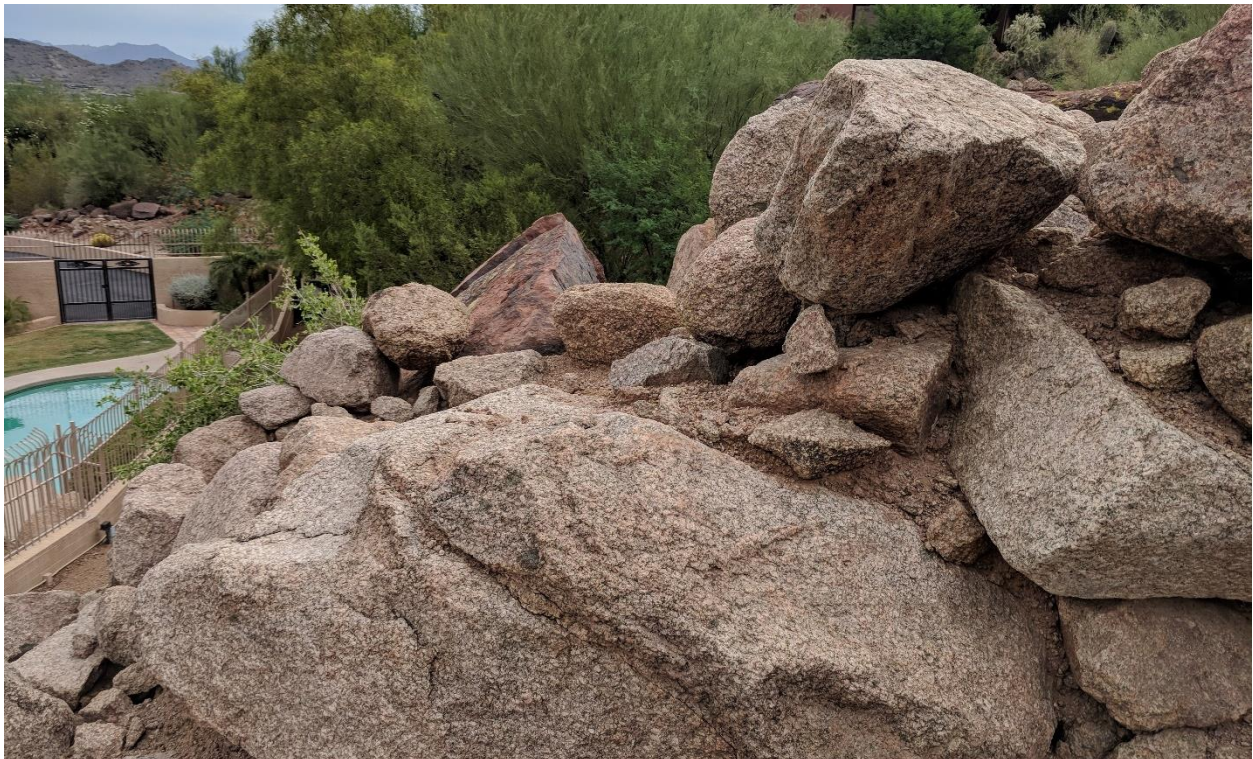
Figure 10: Photograph showing large boulder cluster upslope south of the property
