Town Hall Optimization

Essential Functional Elements

Floor Plan Options

February 28, 2019

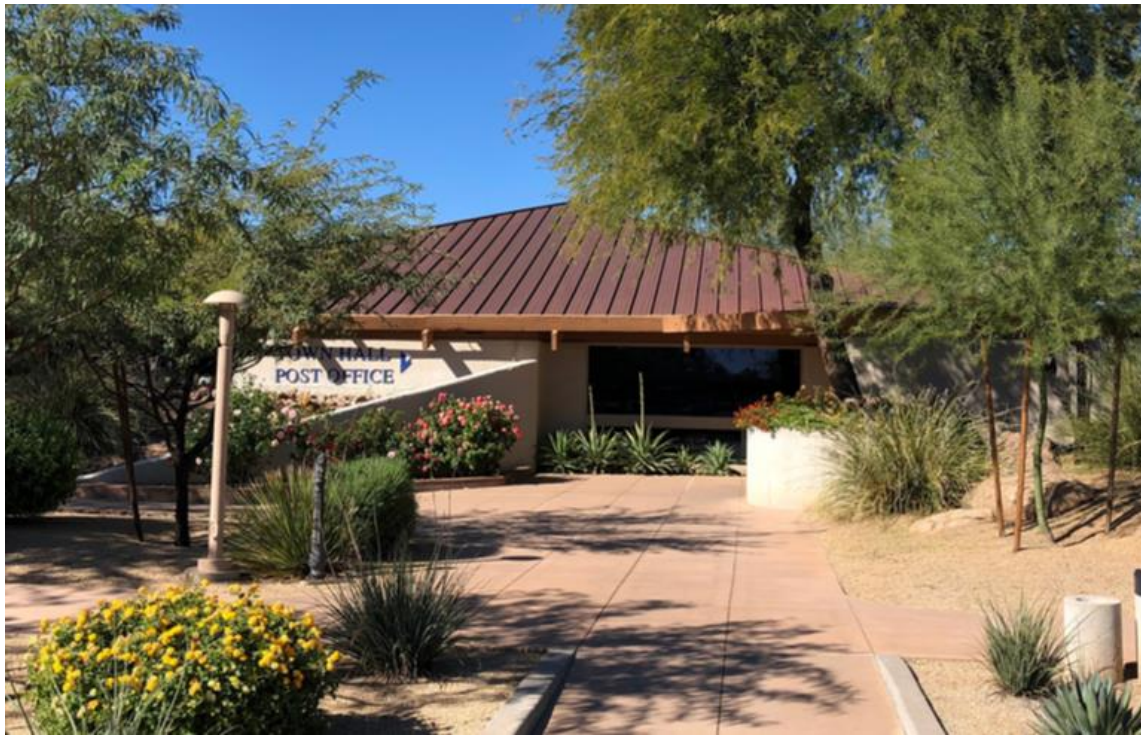
Existing conditions

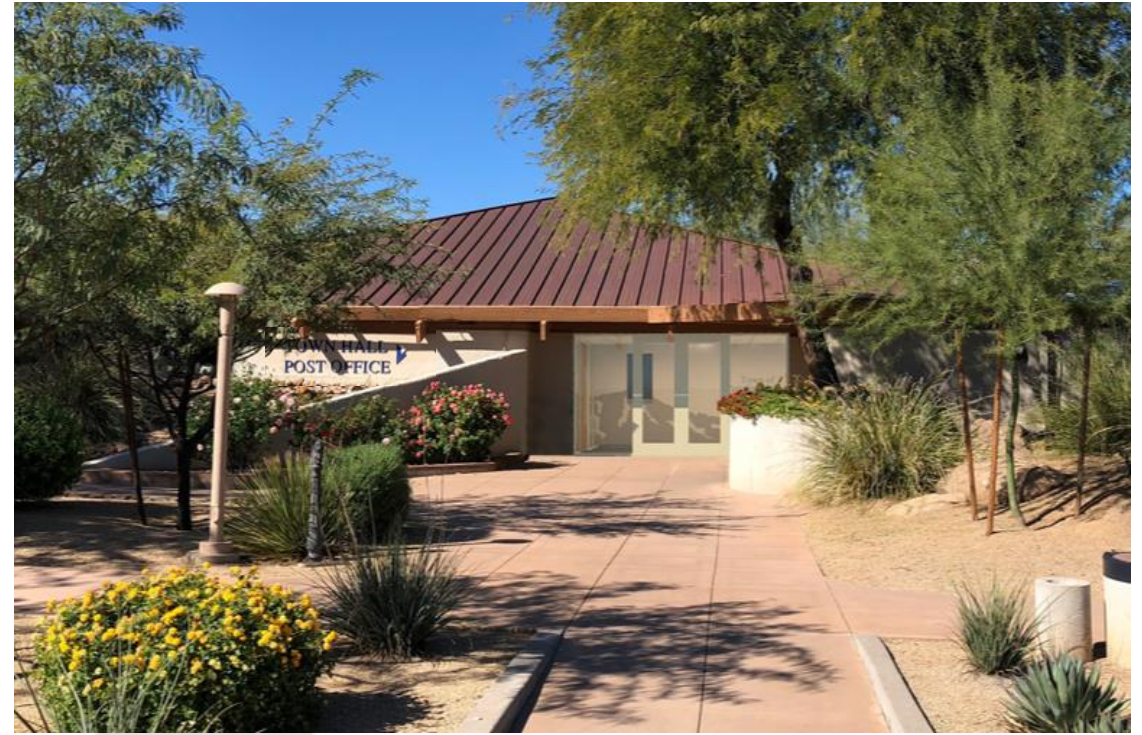
- Clear and direct access
 - Entry doors facing the parking lot
 - Logical flow

Proposed new entry

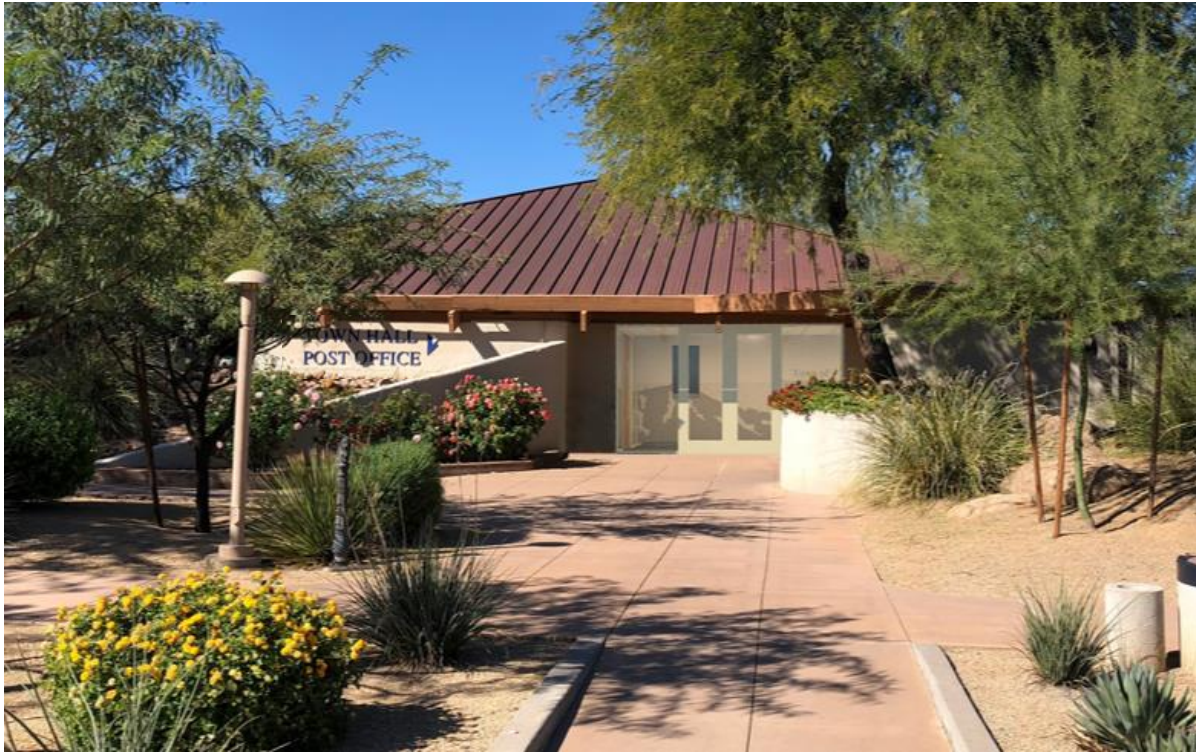
New front entry

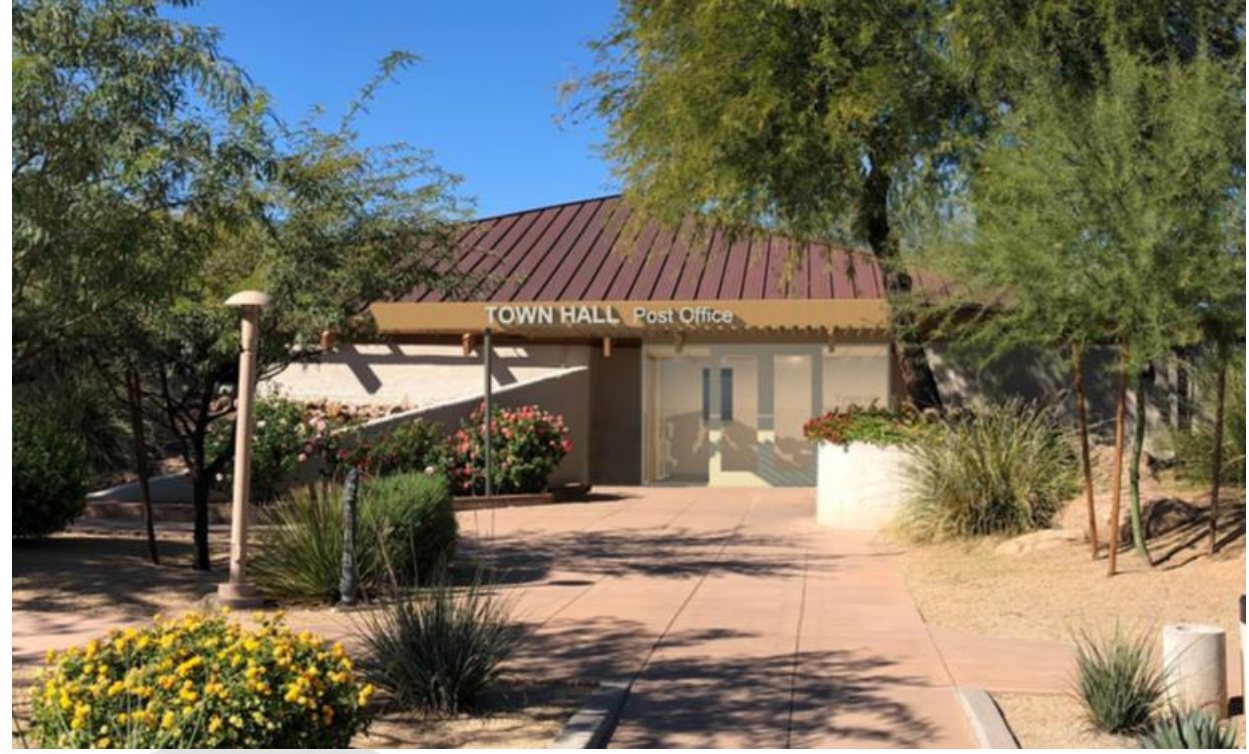
New front entry with shade canopy

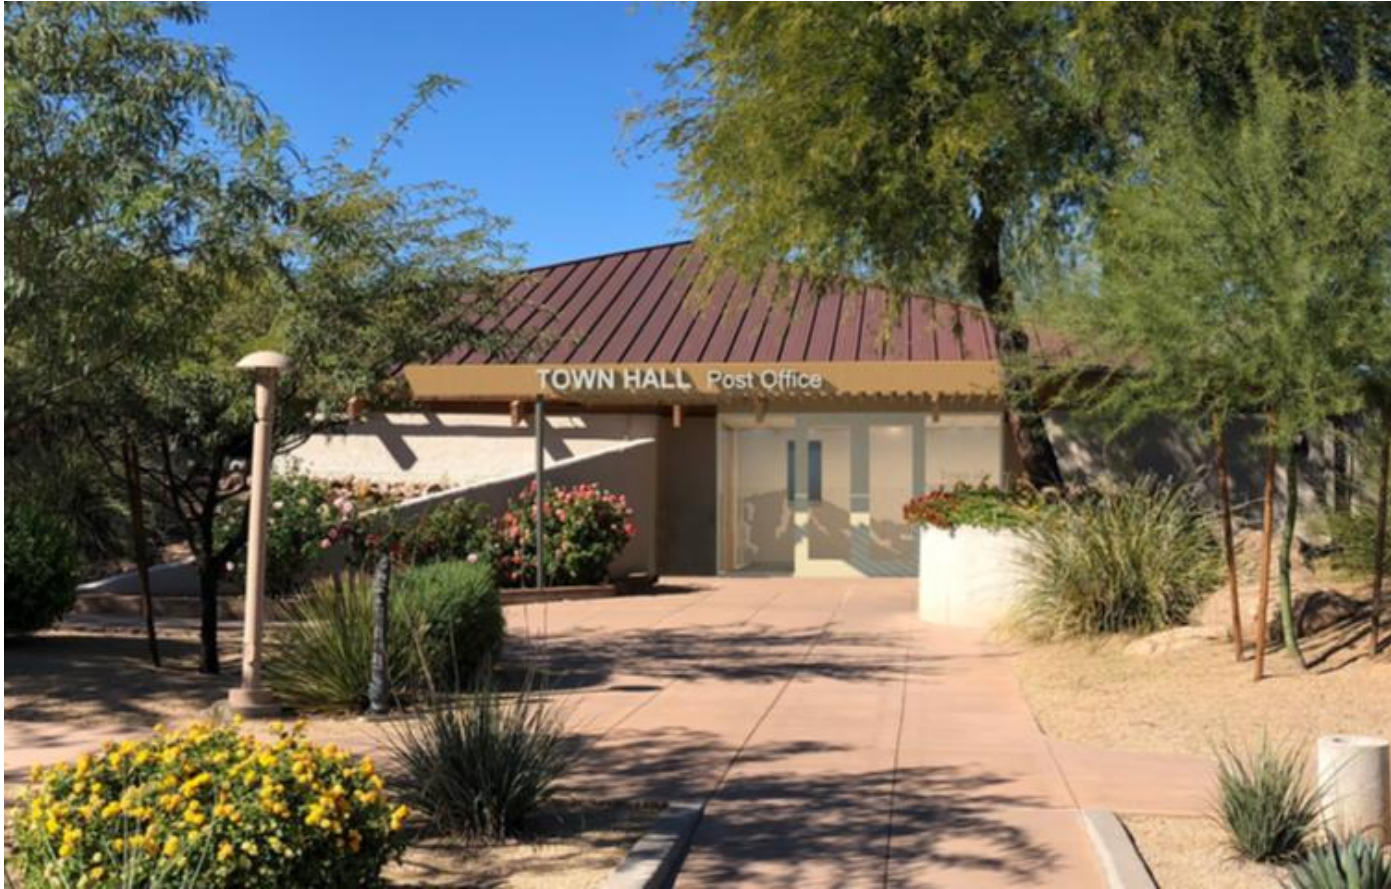
Shade Trellis
with Signage
\$51,400

- Budget
 - \$47K for design & construction administration
 - \$293K remaining for construction
- Current cost estimate (Essential functional elements)
 - IT office space, \$221,000
 - IT office space and new air handler, \$236,000
 - IT office space, new air handler, and front entry, \$352,000
- Additional options & cost
 - Option #1 shade trellis with exterior signage, \$51,400
 - Option #2 interior wayfinding signage, \$4,800

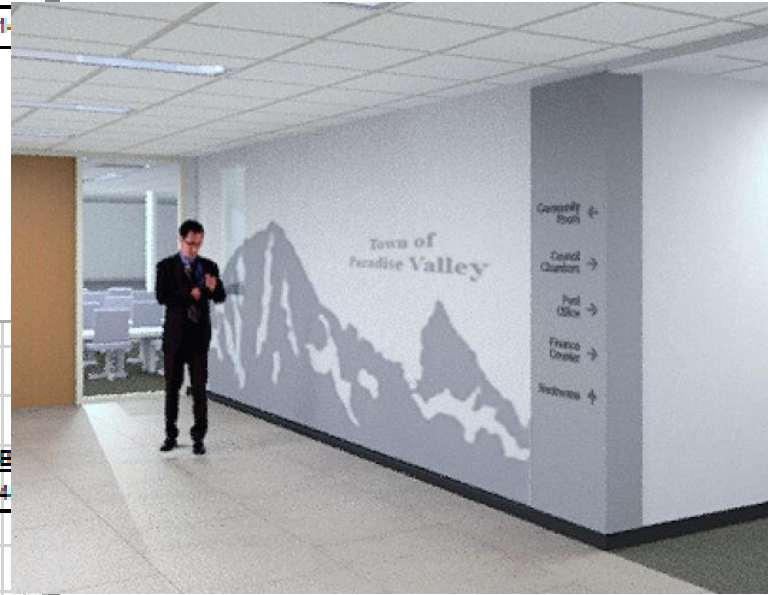
Option #2

Interior
Wayfinding
Signage
\$4,800
