ROCK CUT SLOPE STABILITY ANALYSIS

PROPOSED CUSTOM HILLSIDE RESIDENCE

7550 NORTH HUMMINGBIRD LANE
PARADISE VALLEY, ARIZONA 85253

Project 25998

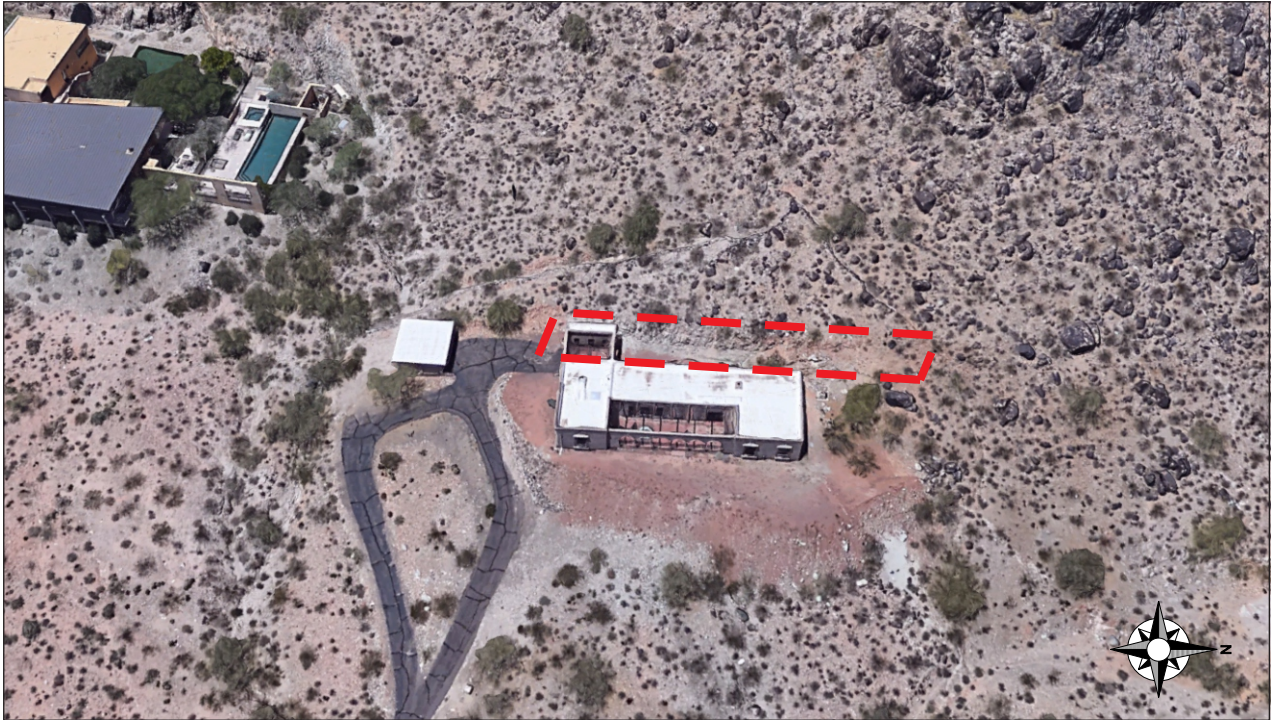
OBLIQUE AERIAL PHOTOGRAPH OF THE SITE, SHOWING THE CURRENT SITE CONDITIONS. THE EXISTING CUT SLOPE IS LOCATED ALONG THE WEST SIDE OF THE SITE SHOWN IN THE AERIAL PHOTOGRAPH (OUTLINED IN RED).

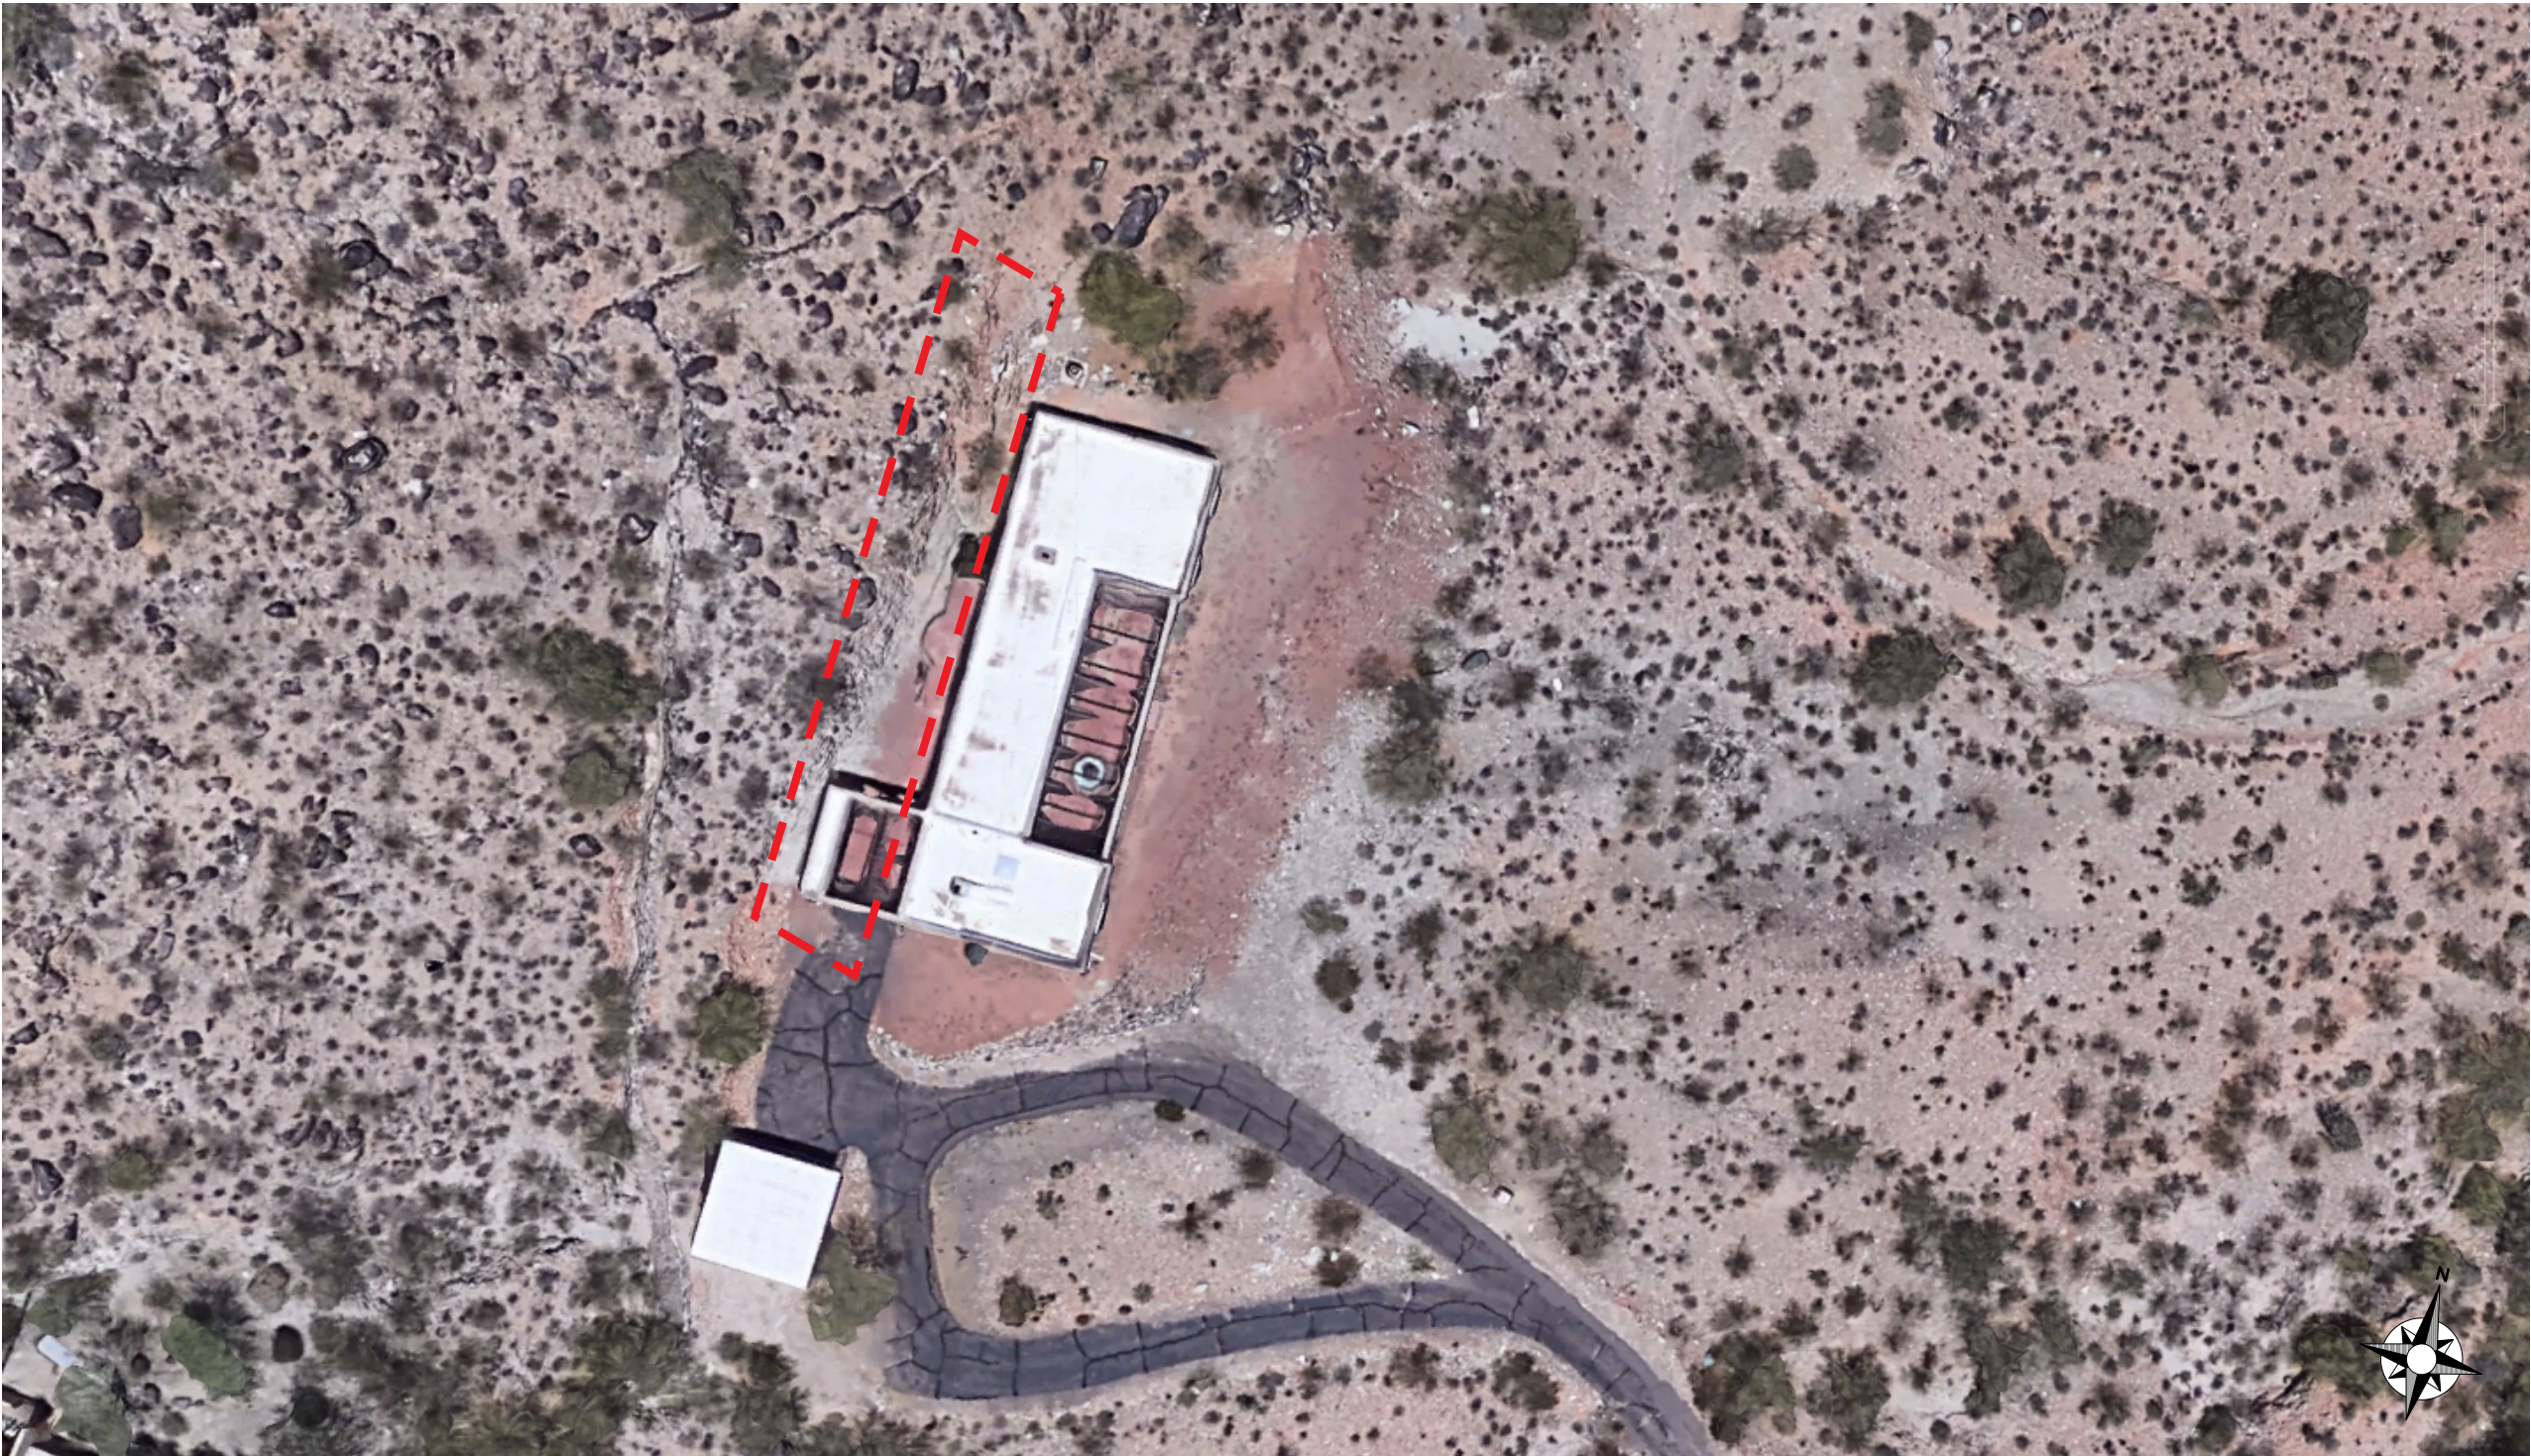
GENERAL INFORMATION:
1) SLOPE HEIGHT (MAX): 16 FEET
2) GENERAL STRIKE: 10 DEGREES
3) MAX DIP: 80 DEGREES
4) DIP RANGE: 65-80 DEGREES
5) SLOPE STRUCTURE: HEAVILY BROKEN
ROCK MASS

MAIN SLOPE:
NORTH-NORTHEAST TO SOUTH-
SOUTHWEST TRENDING CUT SLOPE;
EAST-SOUTHEAST DIPPING;
WEST SIDE OF PROPOSED BUILD AREA

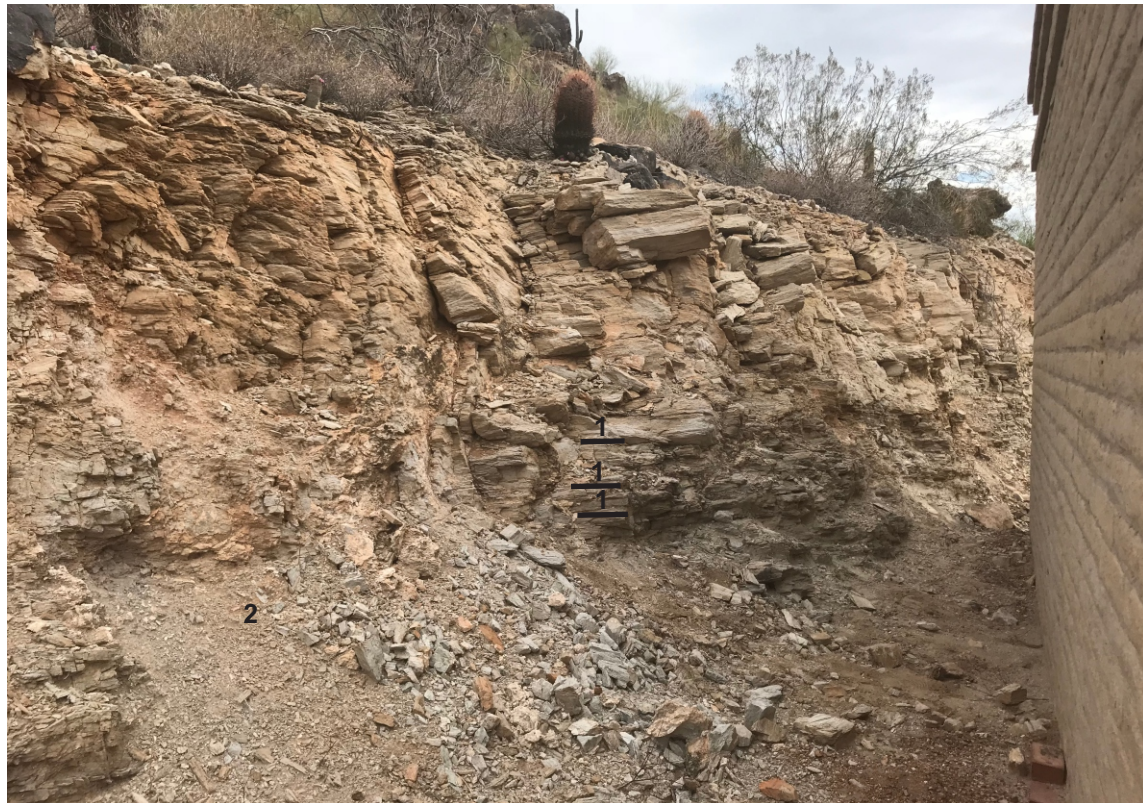
FACING NORTH

1) FOLIATION OF CUT SLOPE

2) HEAVILY BROKEN ROCK MASS

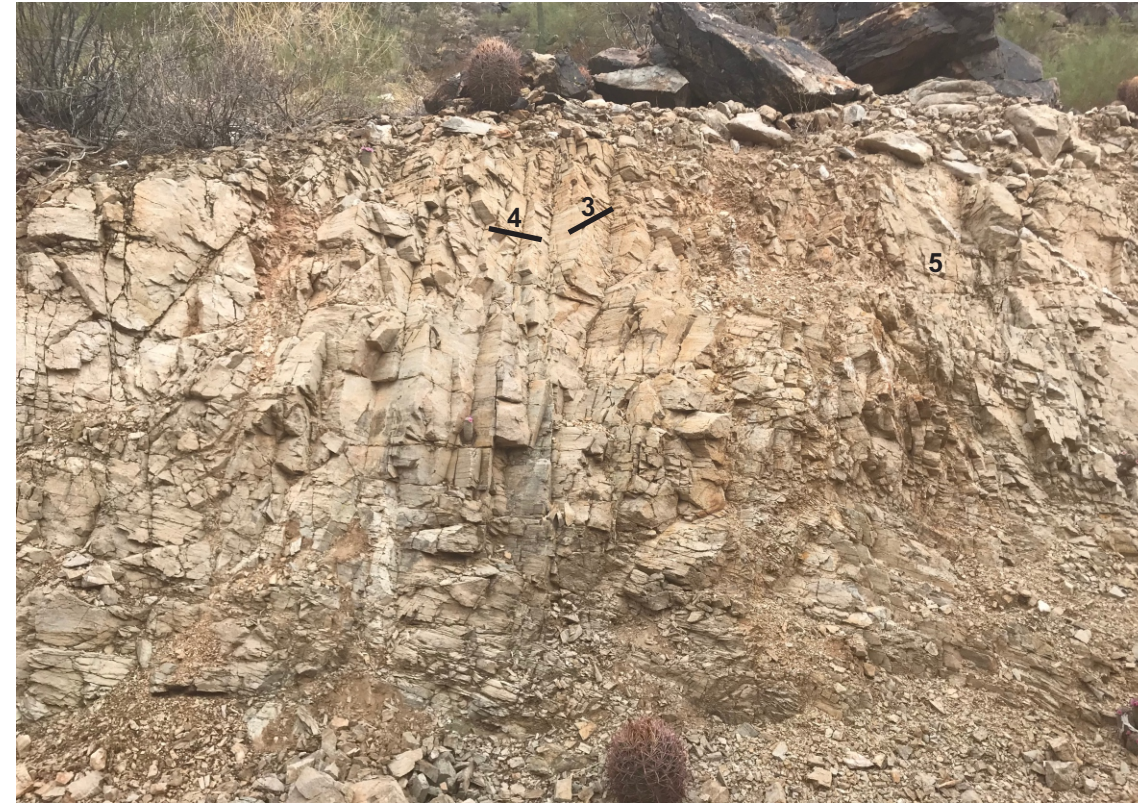
FACING WEST

3) CONJUGATE FRACTURE SET 1
4) CONJUGATE FRACTURE SET 2

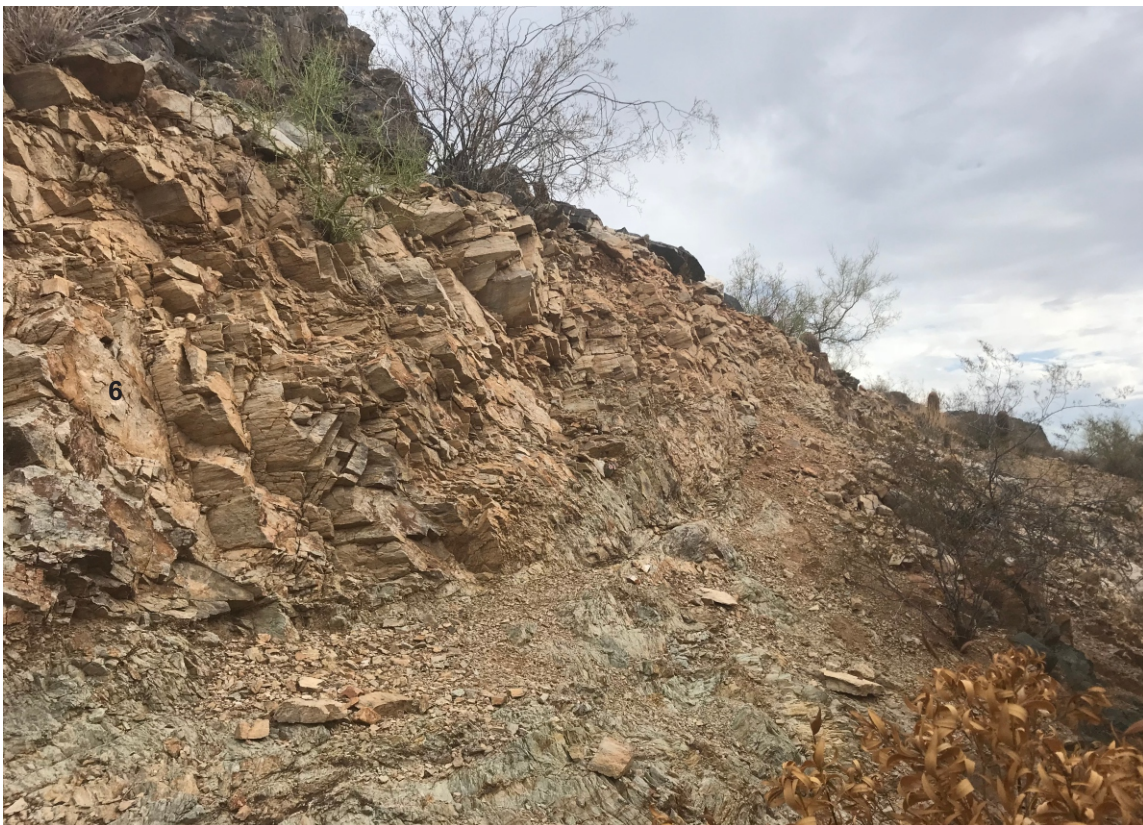
FACING NORTH

5) APPROXIMATE SLOPE ANGLE OF 80 DEGREES

6) APPROXIMATE SLOPE ANGLE OF 65 DEGREES

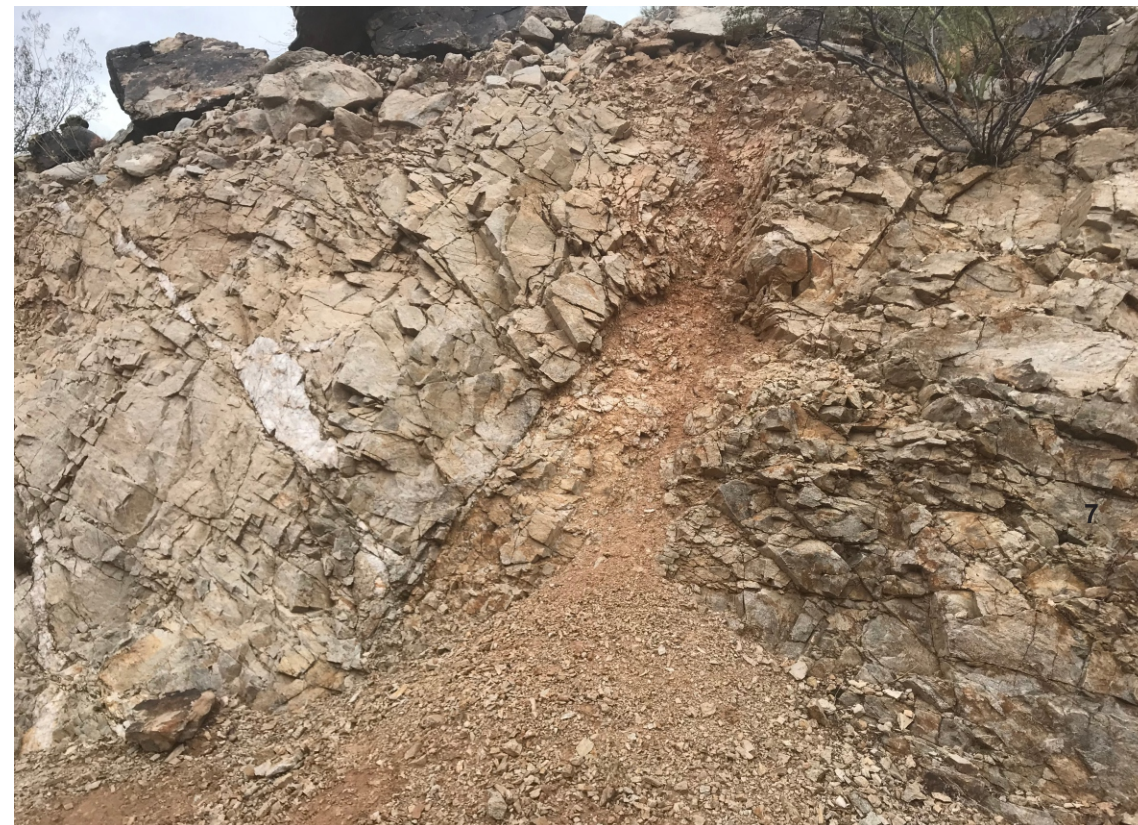
FACING WEST

7) APPROXIMATE SLOPE ANGLE OF 65 DEGREES

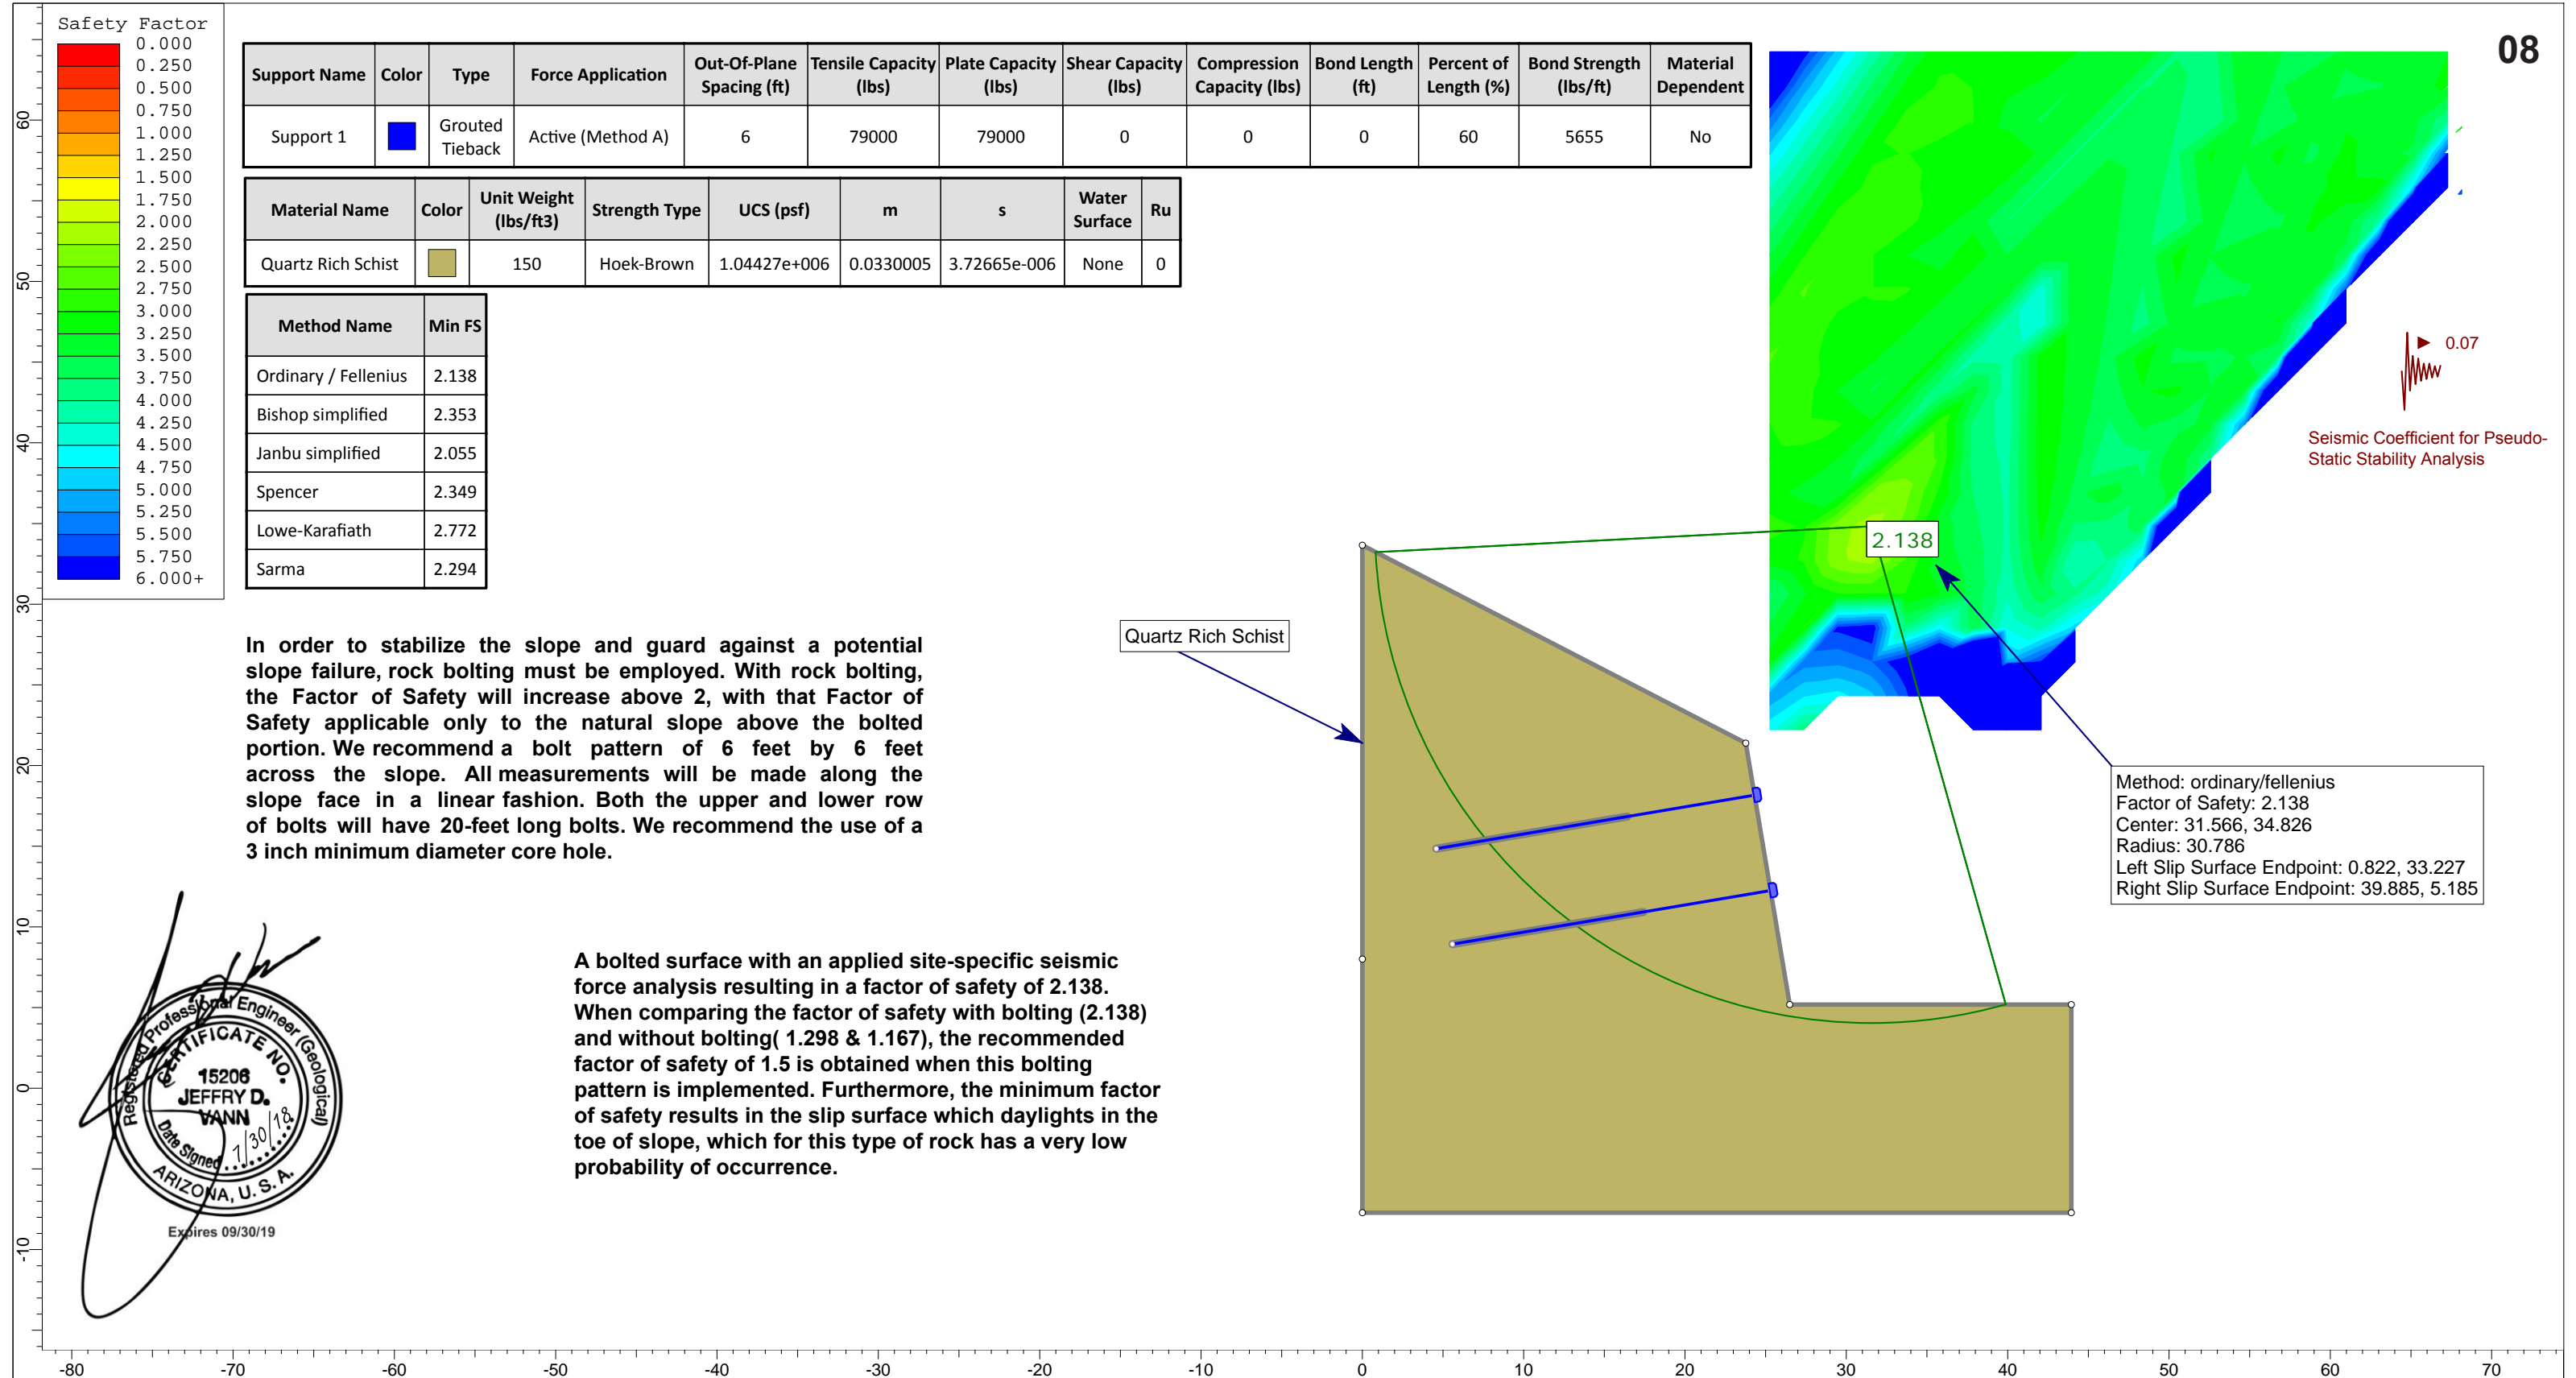
Project			25998 - Proposed Custom Hillside Residence		
Analysis Description			Bolted Condition - Circular Slip Surface		
Drawn By		J. Vann; V. Smith; A. Olaiz	Scale		1:115
Date		7/24/18	Company		Vann Engineering, Inc.
			File Name		25998 - bolted.slm

In order to stabilize the slope and guard against a potential slope failure, rock bolting must be employed. With rock bolting, the Factor of Safety will increase above 2, with that Factor of Safety applicable only to the natural slope above the bolted portion. We recommend a bolt pattern of 6 feet by 6 feet across the slope. All measurements will be made along the slope face in a linear fashion. Both the upper and lower row of bolts will have 20-feet long bolts. We recommend the use of a 3 inch minimum diameter core hole.

A bolted surface with an applied site-specific seismic force analysis resulting in a factor of safety of 2.138. When comparing the factor of safety with bolting (2.138) and without bolting(1.298 & 1.167), the recommended factor of safety of 1.5 is obtained when this bolting pattern is implemented. Furthermore, the minimum factor of safety results in the slip surface which daylight in the toe of slope, which for this type of rock has a very low probability of occurrence.

Method: ordinary/fellenius
Factor of Safety: 2.138
Center: 31.566, 34.826
Radius: 30.786
Left Slip Surface Endpoint: 0.822, 33.227
Right Slip Surface Endpoint: 39.885, 5.185
