# FACILITY CONDITION ASSESSMENT

**Town of Paradise Valley**  
6401 East Lincoln Drive  
Paradise Valley, AZ 85253  
Isaac Chavira

Town Hall  
6401 East Lincoln Drive  
Paradise Valley, AZ 85253

July 7, 2025

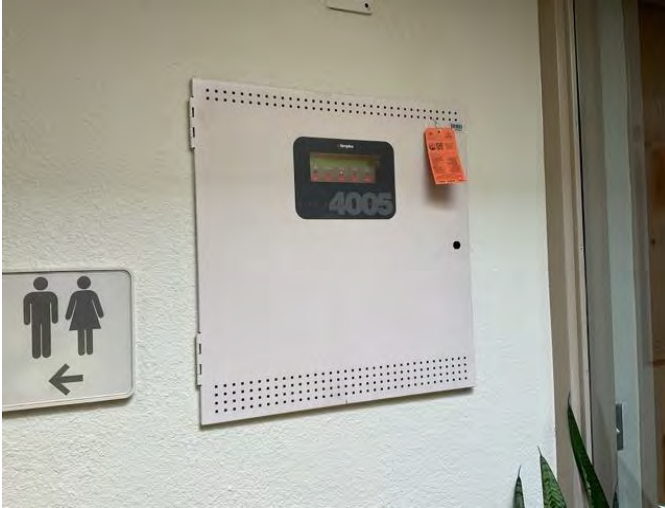
### Fire Alarm Panel in Failed condition.

19 - NONCOMPLIANT FIRE ALARM PANEL

Uniformat Code: D7050  
Recommendation: **Replace in 2025**

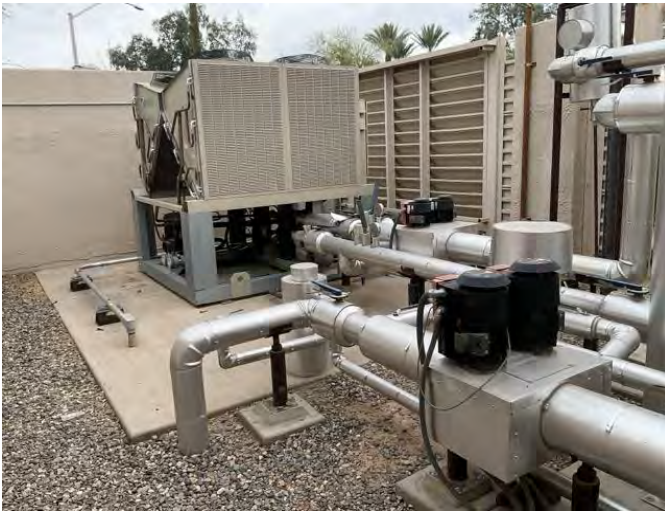
21 - AIR COOLED CHILLER AND PUMPS

An air-cooled chiller with a 2-pipe hydronic system is located at the exterior of the building. The chiller feeds fan-coil units located throughout the building. The chiller was replaced in 2023 with an expected useful life beyond the reserve term. The fan-coil units are located in the ceiling cavities above the ACT ceiling. The fan-coil units were accessible, and some data-plate information was available along with CSM equipment information. Some units have been replaced over the years with the newest replacements in 2023/2024. There are several original 2005 units that are functional but will need upgrading in the near term. Supplemental climatization is with ductless mini-split heat pumps which are anticipated for replacement in the term. The Building Automation System has been upgraded with a digital system in 2023 and is reported to function as expected. The electrical system appears to have been upgraded in 1996 and is of sufficient capacity and functionality for the near term but will need an additional upgrade in the term. There is no emergency backup power present for the building. The plumbing infrastructure is reported to being upgraded in 2005 during the west expansion. Restroom fixtures are reported to have been replaced during a 2019 renovation. An electric water heater was replaced in 2024, and an on-demand instantaneous water heater was installed in 2019. Both water heaters are functioning as expected. Except for fire extinguishers throughout the building with current inspection tags, there is not a system-wide fire suppression system. The fire alarm system is non-functional with connectivity issues with the fire alarm control panel. The exit lights appear to be functional throughout the building, but some older fixtures will need upgrading in the future. All MEPF assets are budgeted and anticipated for replacement based on condition and expected remaining useful life.

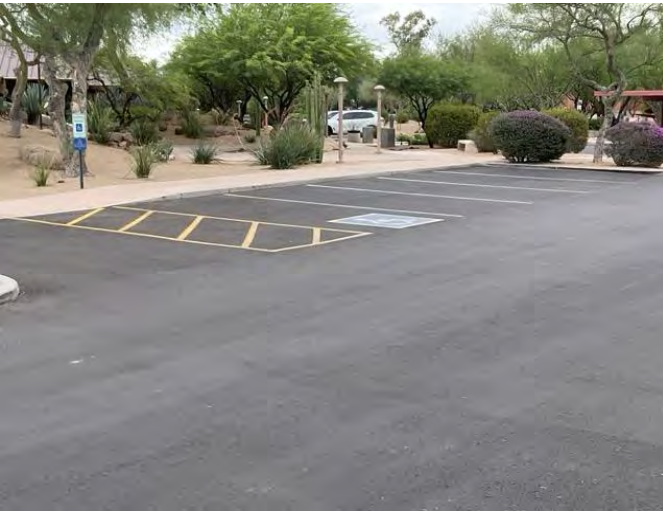
27 - MAIN PARKING AREA

The asphalt drives and parking areas are original pavements with recent sealing and striping. No open cracks or potholes are observed. The concrete sidewalks are observed to be adequate with no cracking observed. Site lighting is with LED pole fixtures and building-mounted fixtures. A fountain is located at the unused entrance and is non-functional with standing stagnant water.
