# FACILITY CONDITION ASSESSMENT

**Town of Paradise Valley**  
6401 East Lincoln Drive  
Paradise Valley, AZ 85253

Fire Station 91  
8444 North Tatum Boulevard  
Paradise Valley, AZ 85253

July 8, 2025

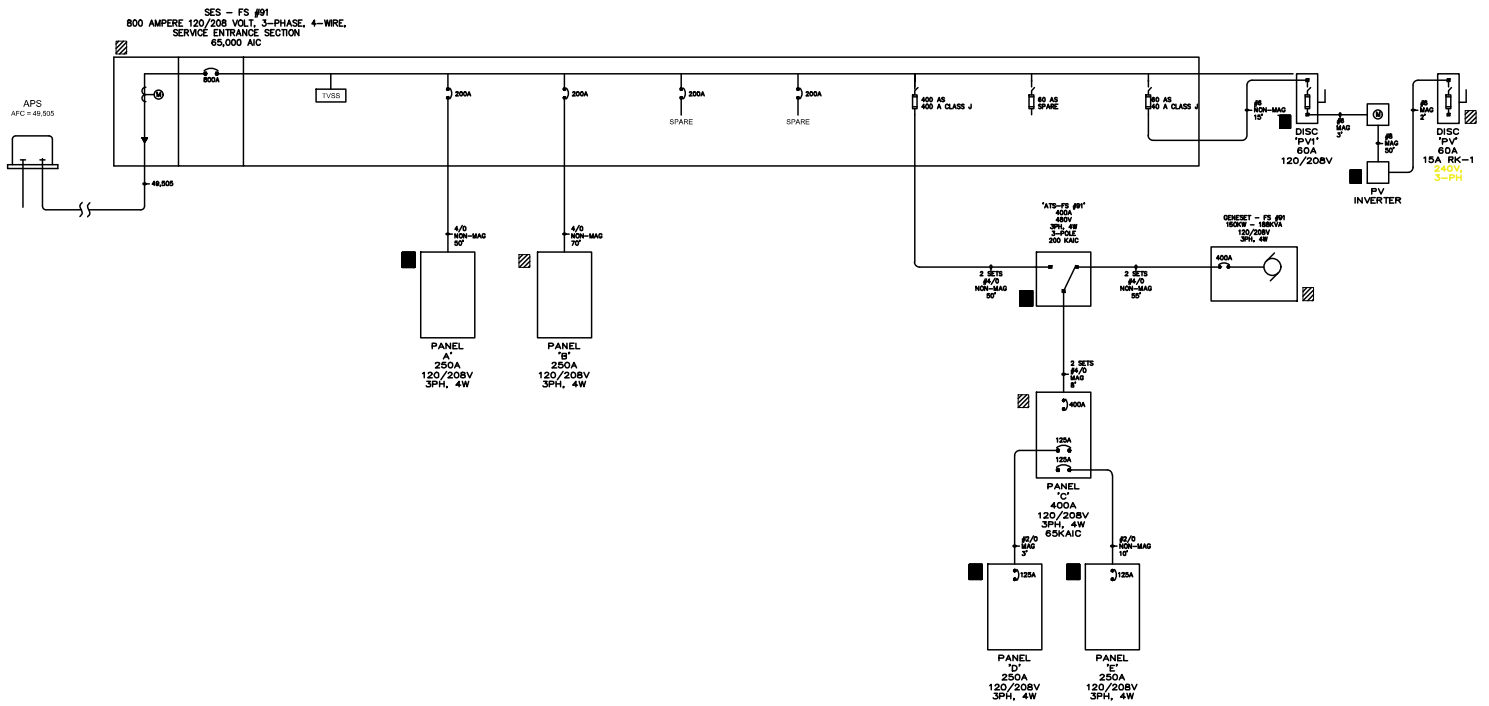
# FIRE STATION #91

The electrical system's overall single line diagrams are shown in the following figures below. Each individual single line is shown with the associated field report that contains the facilities equipment technical specifications and ratings, based upon visual observations. The actual field notes should be referenced for existing conditions as this report focuses on the Short Circuit Fault currents and Arc Flash evaluation. The physical condition of the services and equipment are described by the Excel report but are not formally addressed by this study.

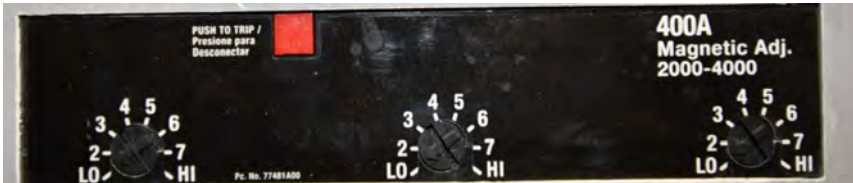
EQUIPMENT NAME:	PANEL 'C'	VOLTAGE:	120/208	PHASE:	3Ø-4W	AMPS:	400	SCCR:	10K	MAIN:	MCB
EQUIPMENT TYPE:	PANELBOARD									MODEL:	JXD63B400
MANUFACTURER:	SIEMENS									AMPS:	400
MODEL:		OTHER COMMENTS									
TYPE:		BRANCH BREAKERS: HBL (65K AIC) AND BQD (65K AIC)									
FED FROM:	ATS FS #91										
AFC:											
SETS:	2 SETS										
FEEDER SIZE:	#4/0										
CONDUCTOR TYPE:	CU										
RACEWAY TYPE:	MAGNETIC										
LENGTH:	8'										
MAIN:	400										
OCPD:
