# ROCK CUT SLOPE STABILITY ANALYSIS

PROPOSED CUSTOM HILLSIDE RESIDENCE

7550 NORTH HUMMINGBIRD LANE  
PARADISE VALLEY, ARIZONA 85253

Project 25998

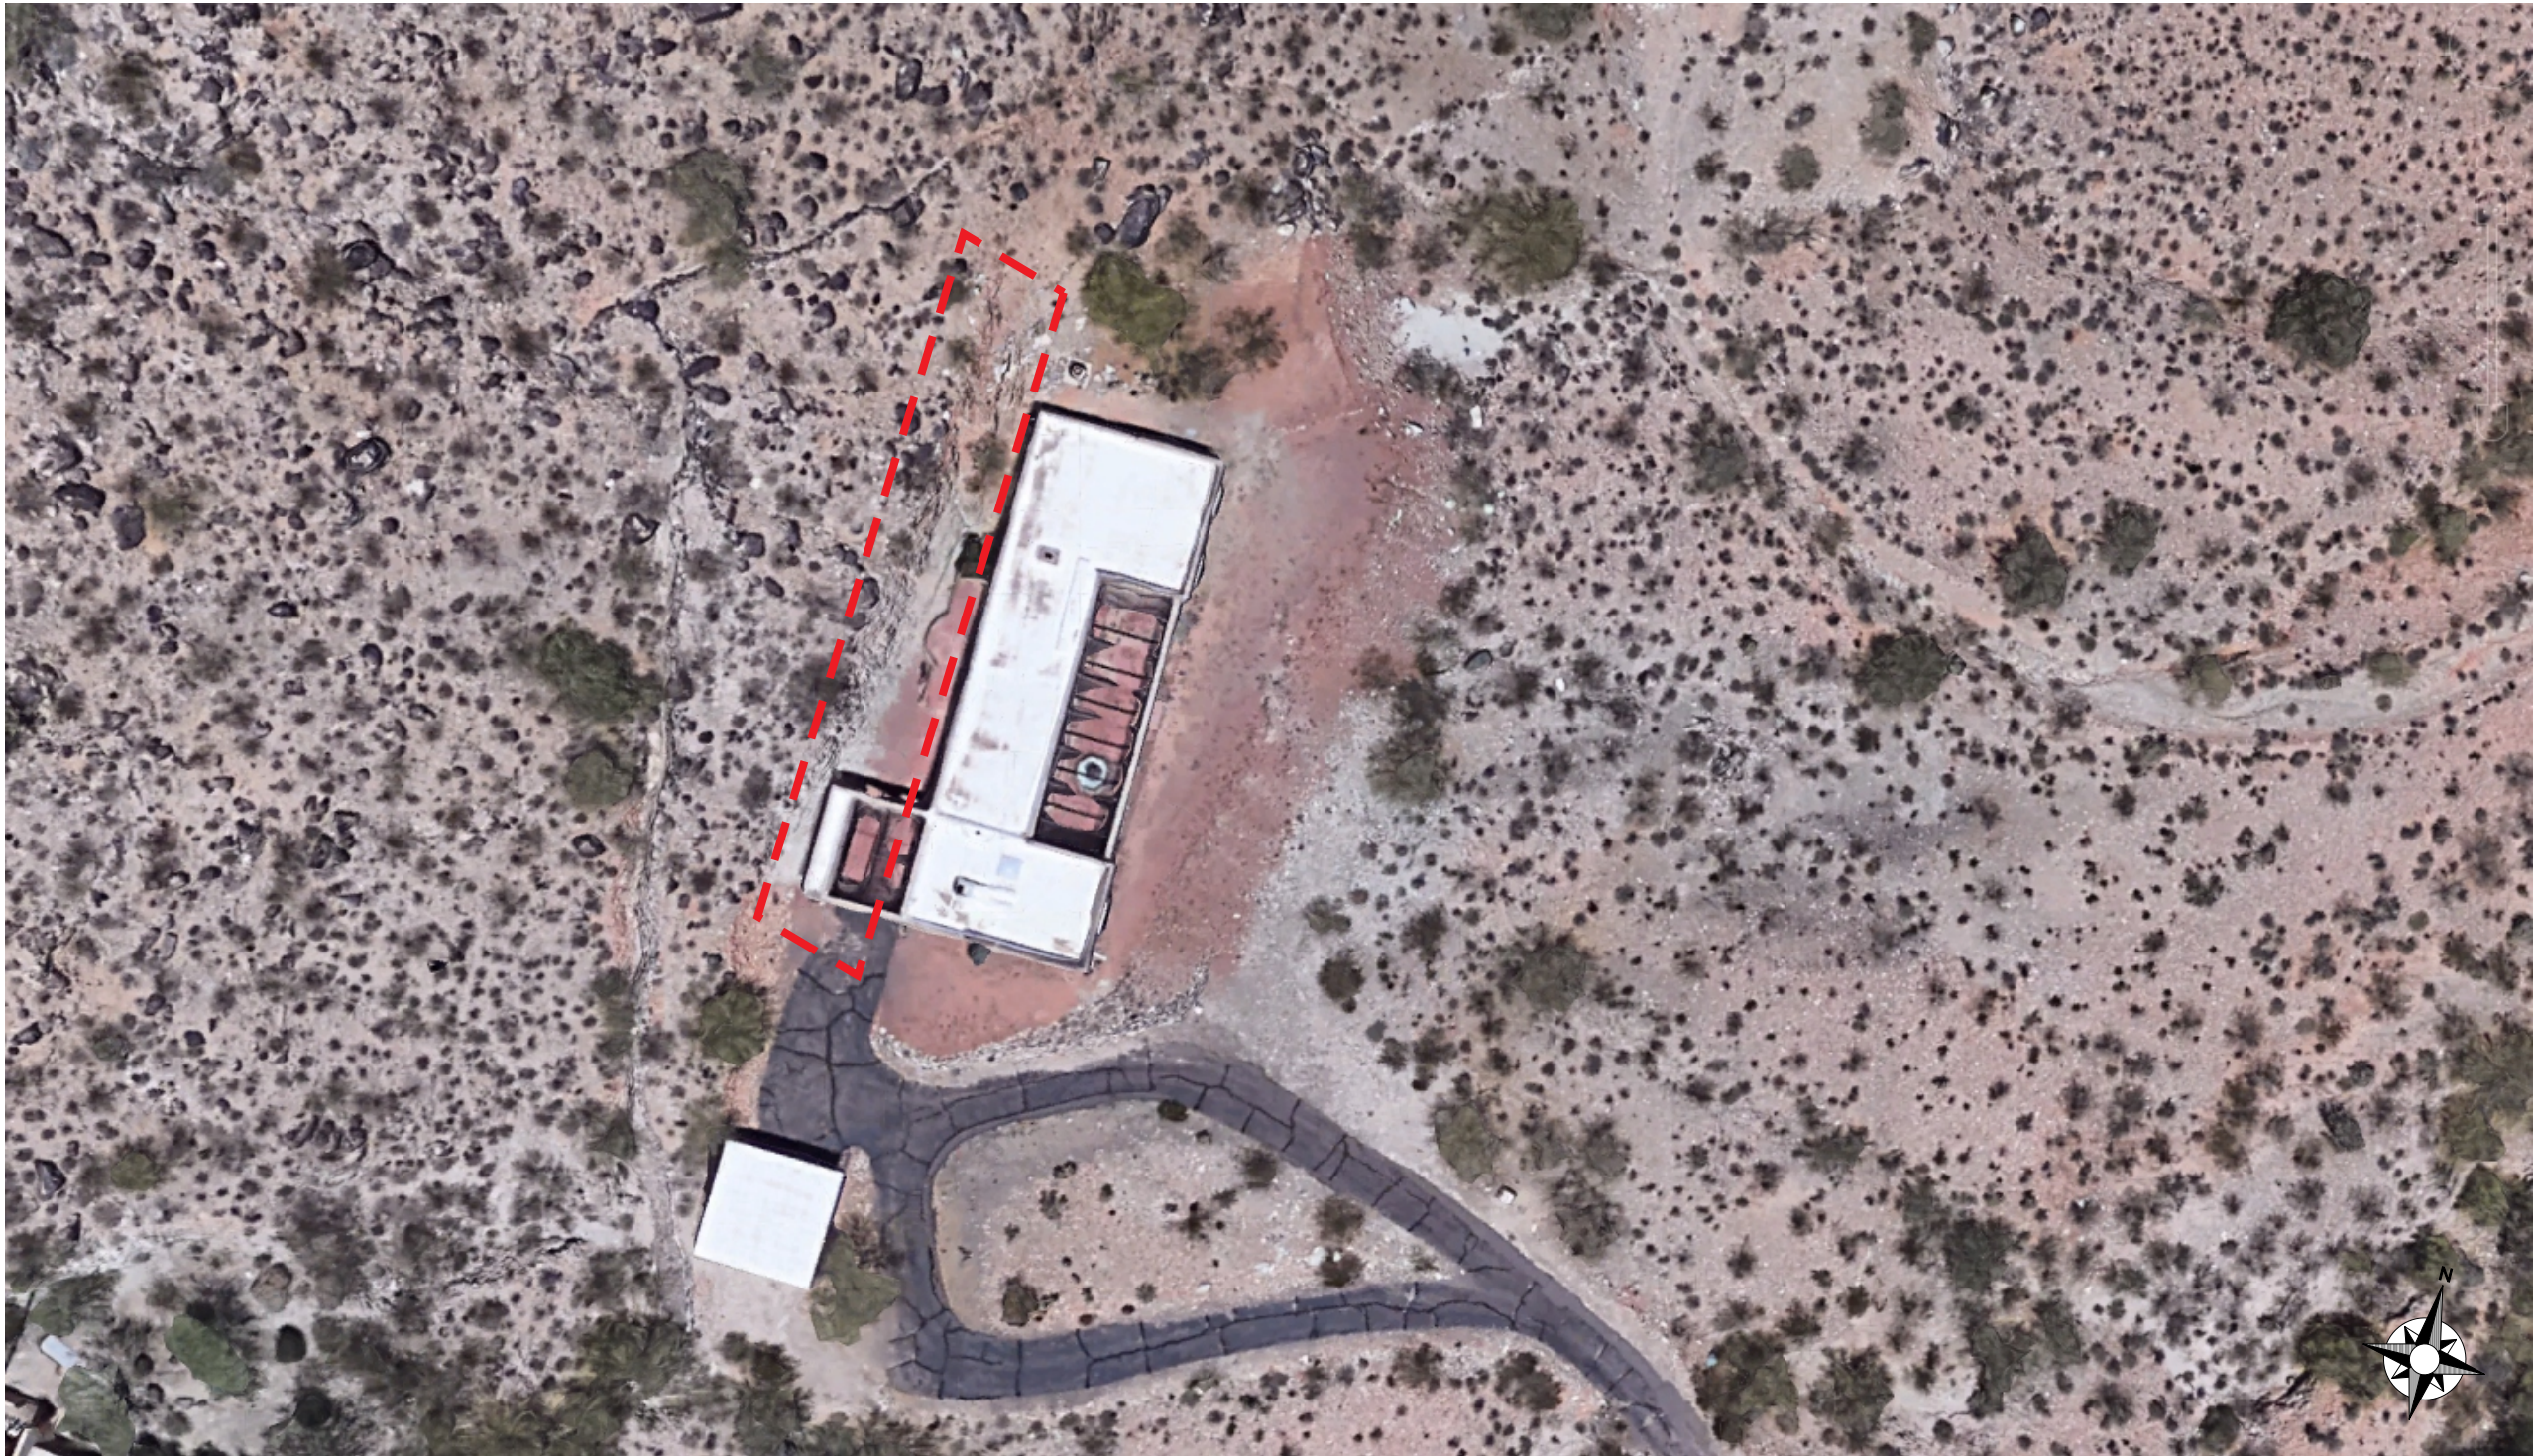
| SITE PLAN | | |

**GENERAL INFORMATION:**  
1) SLOPE HEIGHT (MAX): 16 FEET  
2) GENERAL STRIKE: 10 DEGREES  
3) MAX DIP: 80 DEGREES  
4) DIP RANGE: 65-80 DEGREES  
5) SLOPE STRUCTURE: HEAVILY BROKEN  
ROCK MASS

**MAIN SLOPE:**  
NORTH-NORTHEAST TO SOUTH-  
SOUTHWEST TRENDING CUT SLOPE;  
EAST-SOUTHEAST DIPPING;  
WEST SIDE OF PROPOSED BUILD AREA

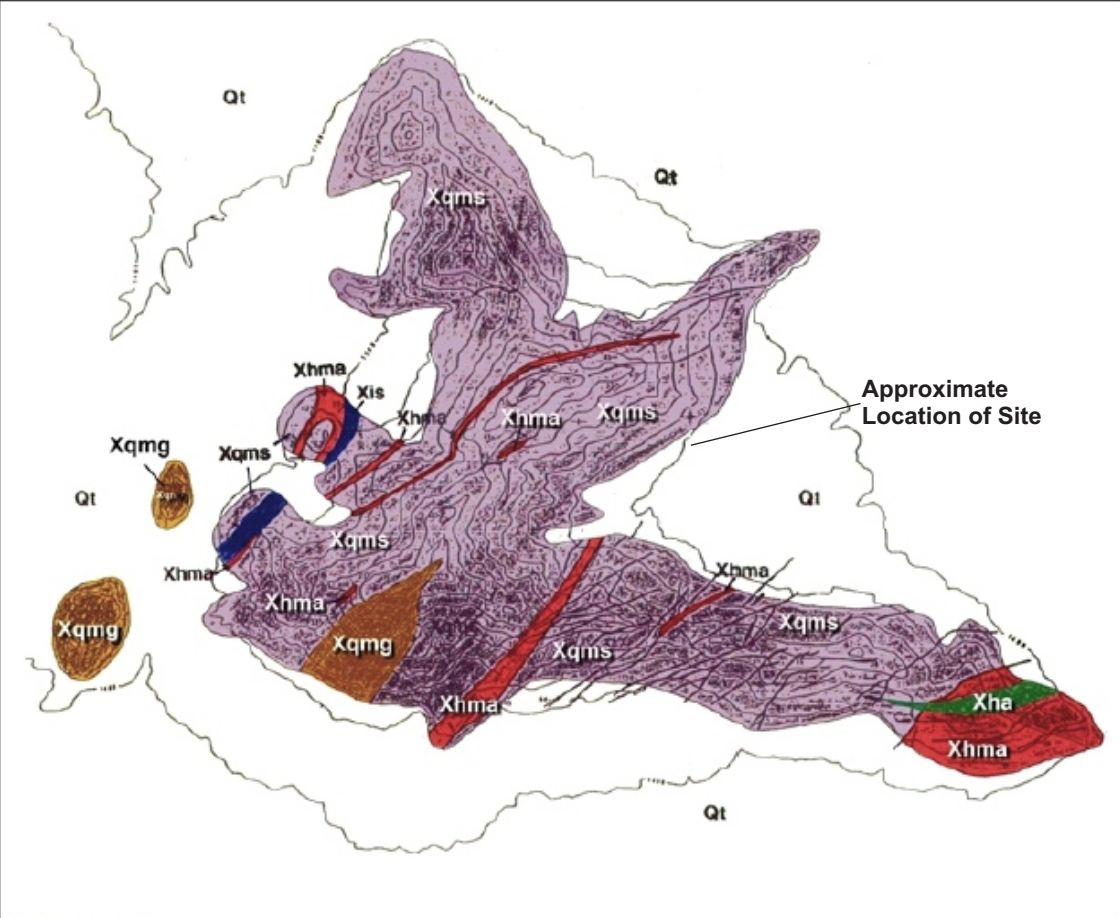
THE ROCK MASS THAT COMPRISES THE SITE IS PREDOMINANTLY QUARTZ - MUSCOVITE SCHIST (Xqms) THAT IS HIGHLY TO MODERATELY WEATHERED AND FRACTURED. REGIONALLY, THE STRIKE OF THE FOLIATION SOUTH OF THE SITE IS APPROXIMATELY 234° WITH A FOLIATION DIP OF 44° TO THE NORTHWEST. FURTHER, THE REGIONAL STRIKE OF THE FOLIATION WEST OF THE SITE IS APPROXIMATELY 228° WITH A DIP OF 27° TO THE NORTHWEST. BOTH SETS OF CONDITIONS SHOULD BE ANTICIPATED AT THE SITE. TO THE NORTH-NORTHWEST OF THE SITE, A PEGMATITE DIKE TRENDS FROM NORTH-NORTHEAST TO WEST-SOUTHWEST (DENOTED BY A SOLID LINE).

THE MAIN CUT IS LOCATED ON THE WESTERN EDGE OF THE SITE. THE ROCKS ASSOCIATED WITH THIS CUT SLOPE ARE PREDOMINANTLY QUARTZ-MUSCOVITE-SCHIST THAT CONTAIN DIFFERENT MAGNITUDES OF FOLIATION. QUARTZ VEINS AND A MAFIC INTRUSION ARE ALSO PRESENT. THE MOST PREDOMINANT DISCONTINUITY ALONG THE WESTERN AND EASTERN 1/3 OF THE SLOPE IS FOLIATION, AND THE MOST COMMON DISCONTINUITIES ALONG THE CENTRAL

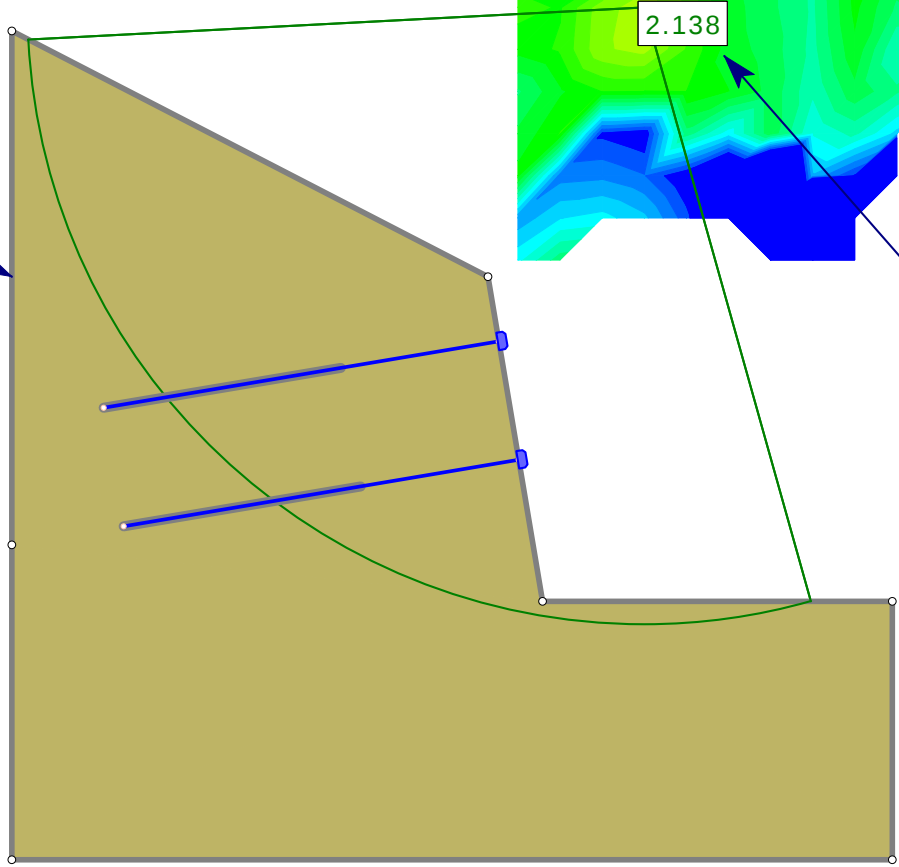
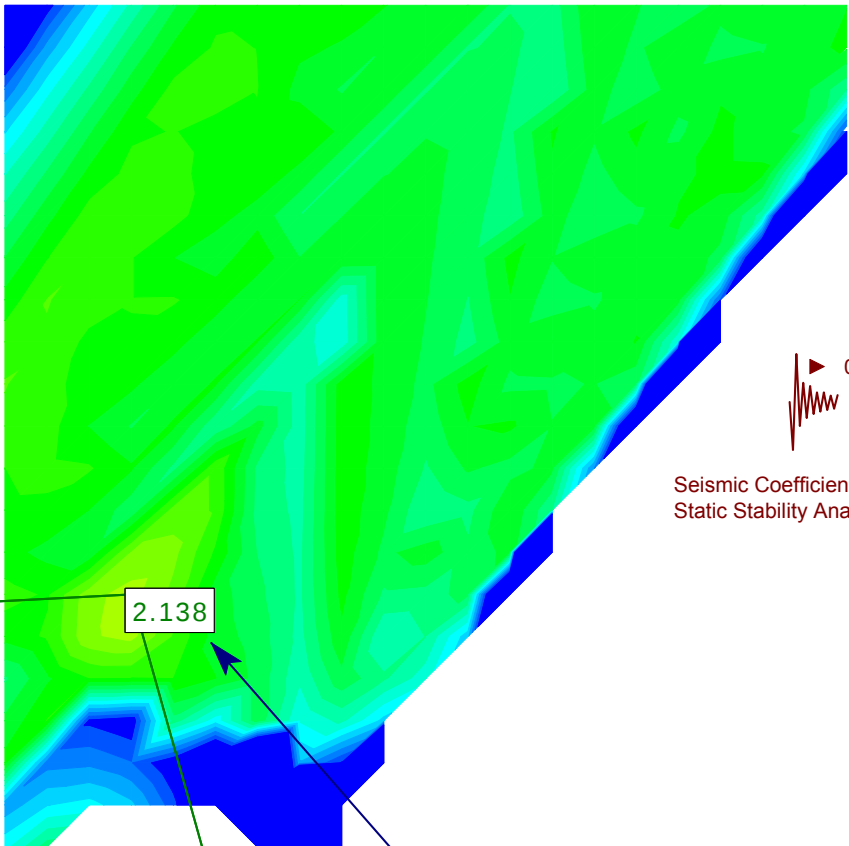
A bolted surface with an applied site-specific seismic force analysis resulting in a factor of safety of 2.138. When comparing the factor of safety with bolting (2.138) and without bolting( 1.298 & 1.167), the recommended factor of safety of 1.5 is obtained when this bolting pattern is implemented. Furthermore, the minimum factor of safety results in the slip surface which daylight in the toe of slope, which for this type of rock has a very low probability of occurrence.

Method: ordinary/fellenius  
Factor of Safety: 2.138  
Center: 31.566, 34.826  
Radius: 30.786  
Left Slip Surface Endpoint: 0.822, 33.227  
Right Slip Surface Endpoint: 39.885, 5.185

In order to stabilize the slope and guard against a potential slope failure, rock bolting must be employed. With rock bolting, the Factor of Safety will increase above 2, with that Factor of Safety applicable only to the natural slope above the bolted portion. We recommend a bolt pattern of 6 feet by 6 feet across the slope. All measurements will be made along the slope face in a linear fashion. Both the upper and lower row of bolts will have 20-feet long bolts. We recommend the use of a 3 inch minimum diameter core hole.

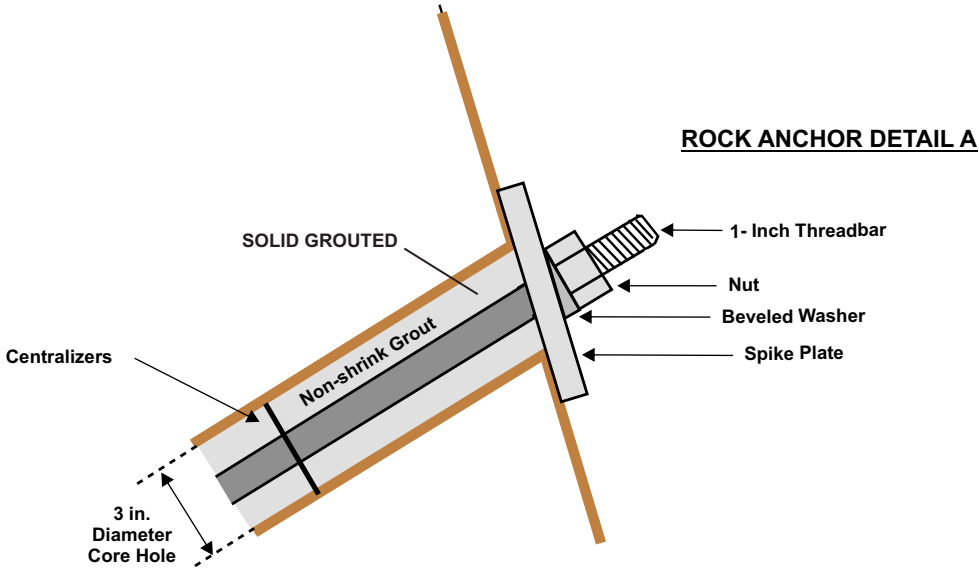
The remediation of the existing cut slope will ensure the structural integrity to remain intact well into the future. It is needed because the visual observations along with the structural data presented in the markland stability analysis show a probability of both planar and wedge failure. The remediation of the existing cut slope will not completely prevent future surface erosion or the possibility of small rock fragments from falling off of the face of the cut slope. If the client desires shotcrete and faux rock, can be used to cover the exposed face of the cut slope and minizmie possibility of detritus falling from the slope.

Two (2) rows of rock bolts should be installed across the cut slope. The bolt lengths are to be 20 feet, using a 1-inch diameter bar with a 3-inch core hole diameter, spaced 6 feet vertical and 6 feet horizontal (6 feet x 6 feet grid). The annular space must be grouted a minimum of 60% of the total length of the bolt (i.e. 12'). Final locations to be marked on-site by Vann
