***BOULDER STABILITY EVALUATION***

***PROPOSED CUSTOM HILLSIDE RESIDENCE***

***7550 NORTH HUMMINGBIRD LANE***

***Project 25998***

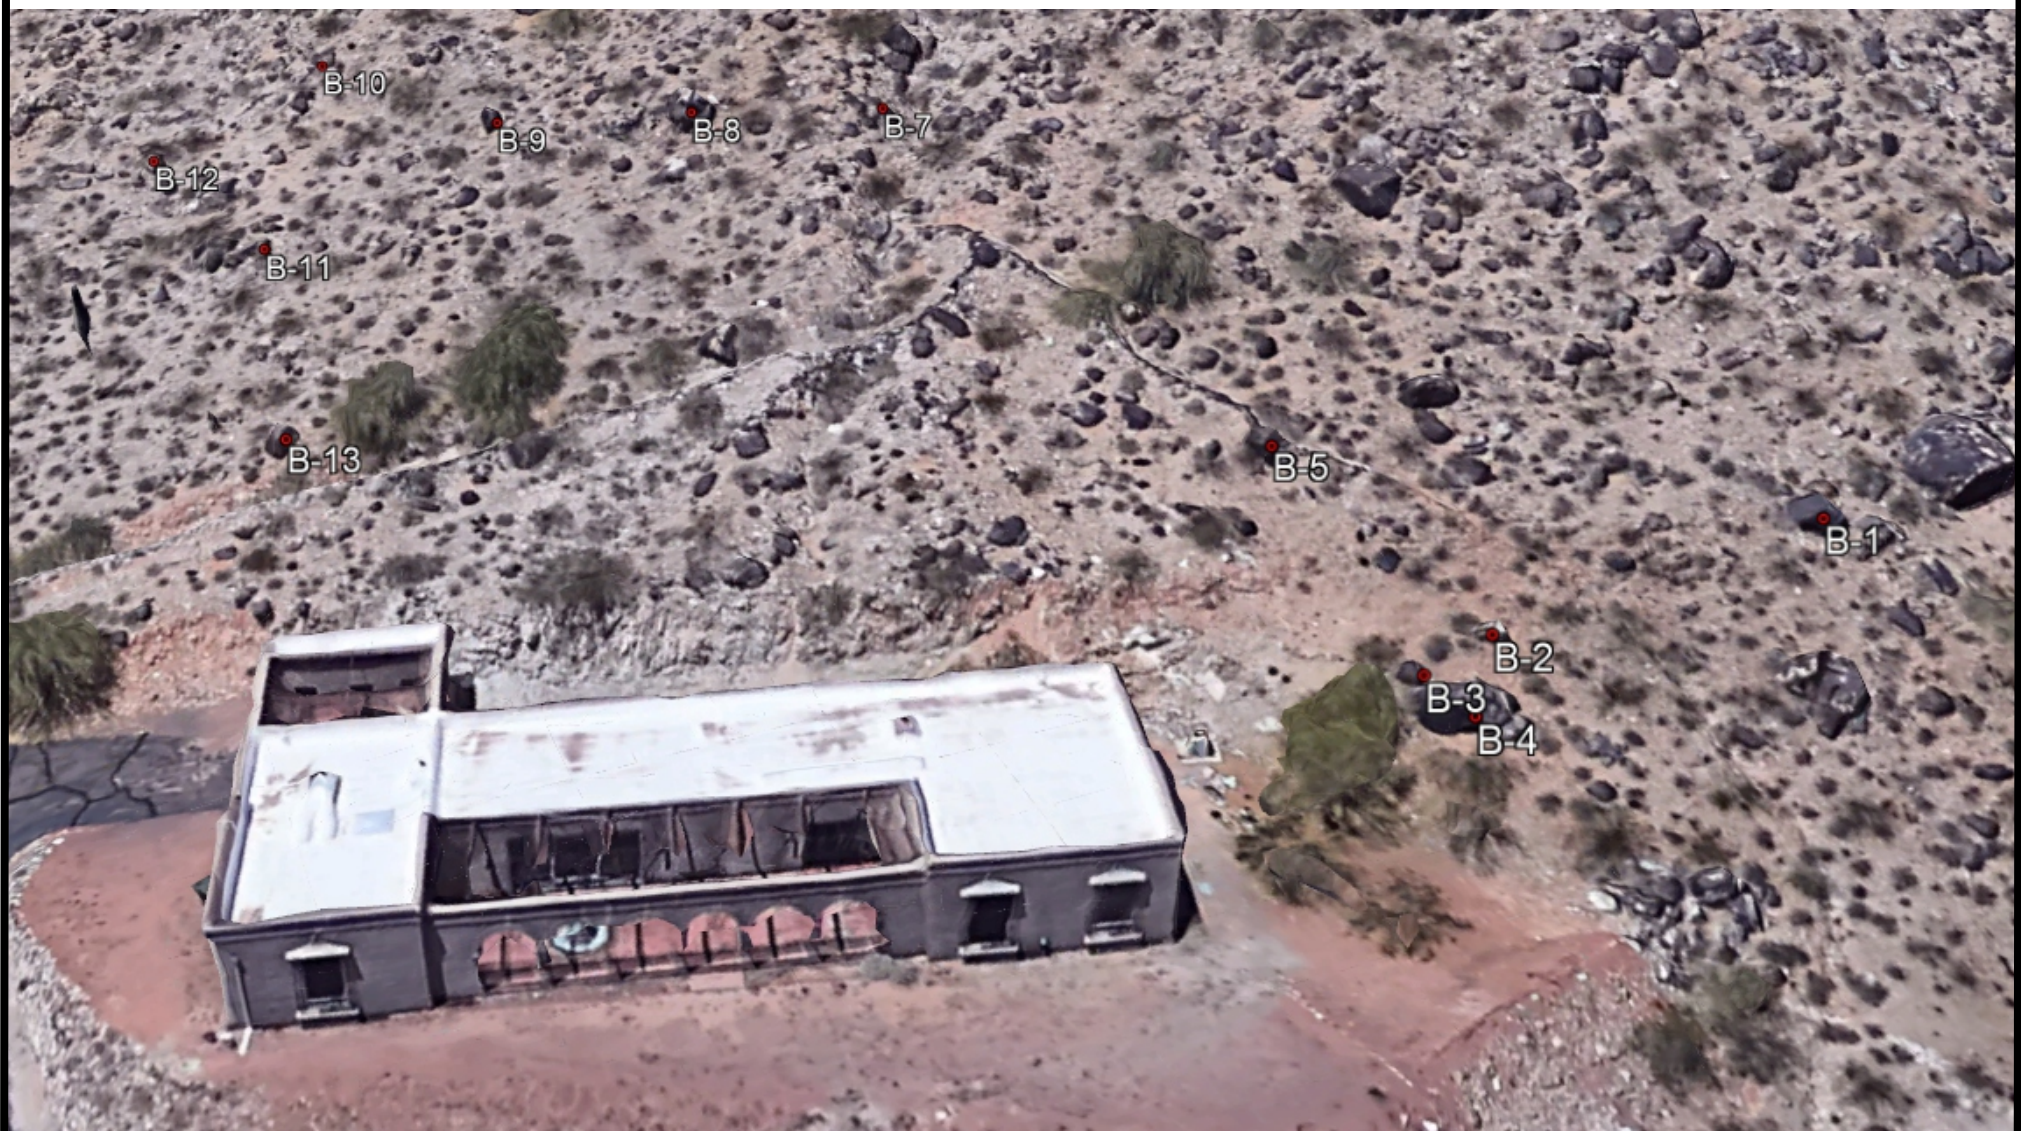
BOULDER LOCATIONS

The subject site is currently occupied by an existing residential structure, detached garage, and asphalt driveway. It is the understanding of this firm that all of the existing structures and hardscape are to be demolished as part of the proposed new custom residence. An existing cut slope, ranging from 5.0 to 16.0 feet high, is present along the west edge of the proposed build area. Several boulders were observed within 10.0 feet of the crest of the cut slope. All boulders evaluated in this study (13 in total) were located within a 200 linear-foot radius upslope from the proposed build area. Refer to the aerial site plan, GPS coordinates, and photographs in Section II of this report for the approximate locations of the studied boulders, which are denoted as B-1 through B-13.
