BOULDER STABILITY EVALUATION

***PROPOSED TONN RESIDENCE
APN 172-47-063
5429 EAST SOLANO DRIVE
PARADISE VALLEY, ARIZONA 85253***

September 27, 2018

Project 24215

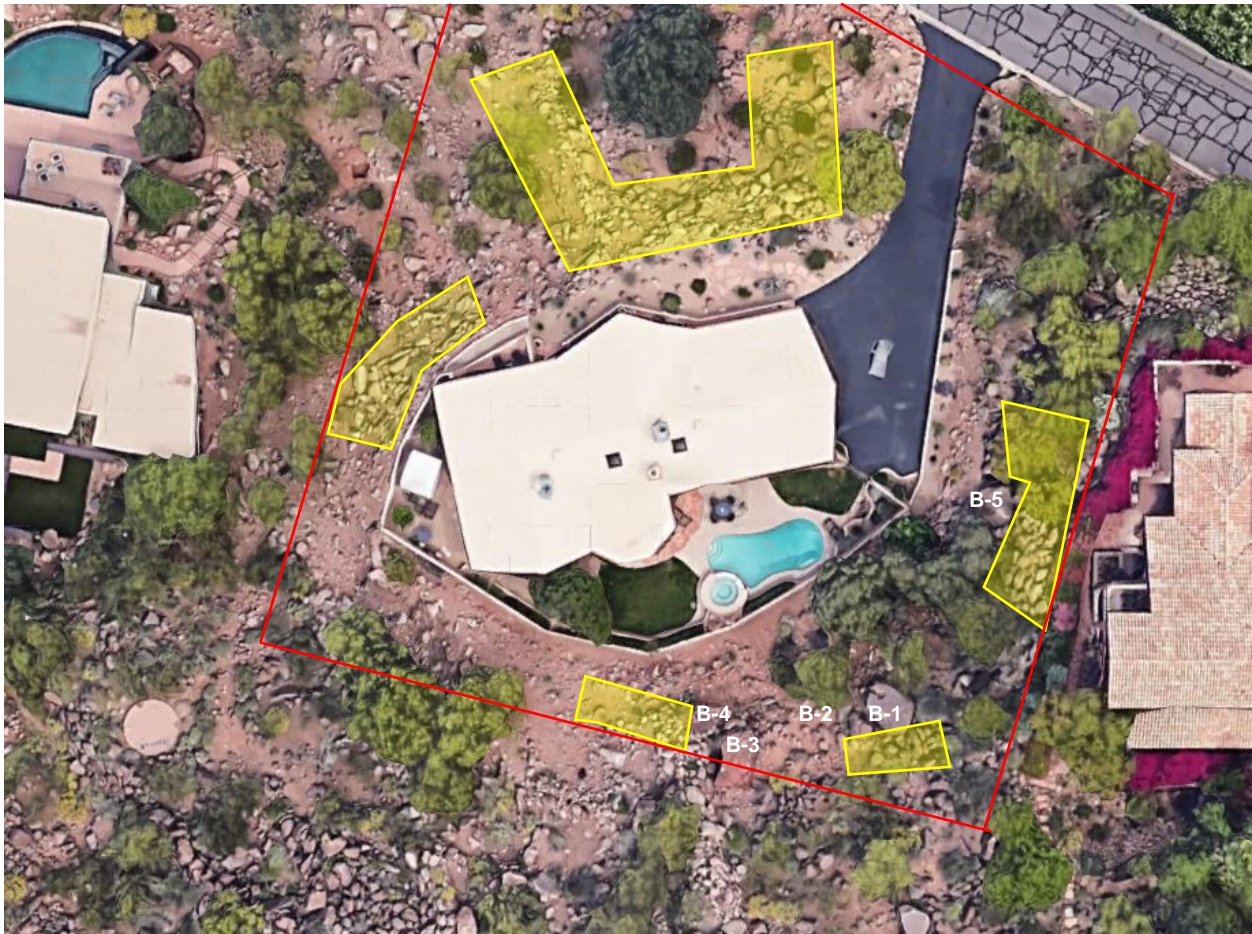
Figure 2: Aerial photograph showing approximate locations of the boulders and the boulder clusters shaded yellow, and the parcel boundary outlined in red
