FACILITY CONDITION ASSESSMENT

Fire Station 92
6539 East Lincoln Drive
Paradise Valley, AZ 85253

172662.25R000-006.468

July 10, 2025

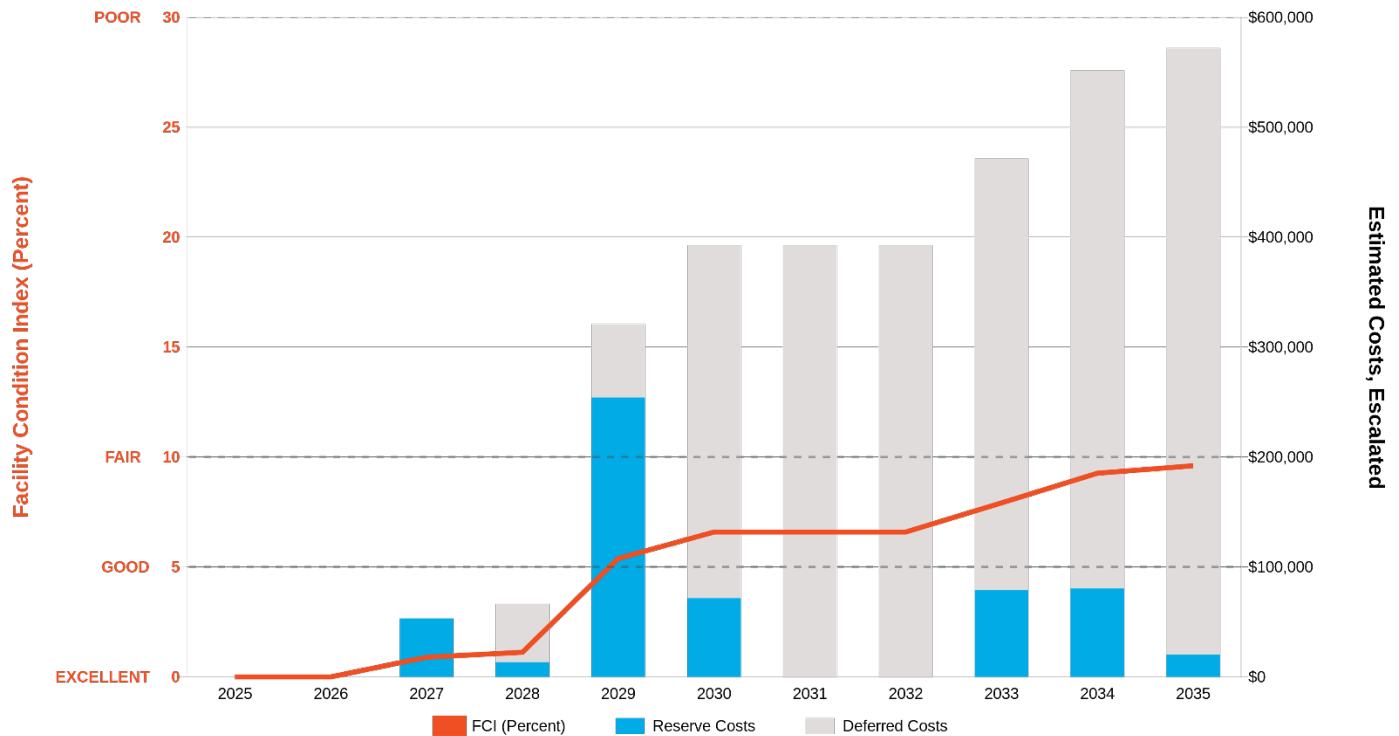
Replacement Value: \$5,956,650.00

Inflation Rate: 3%

Average Needs (per year - over next 10 years): \$51,994.00

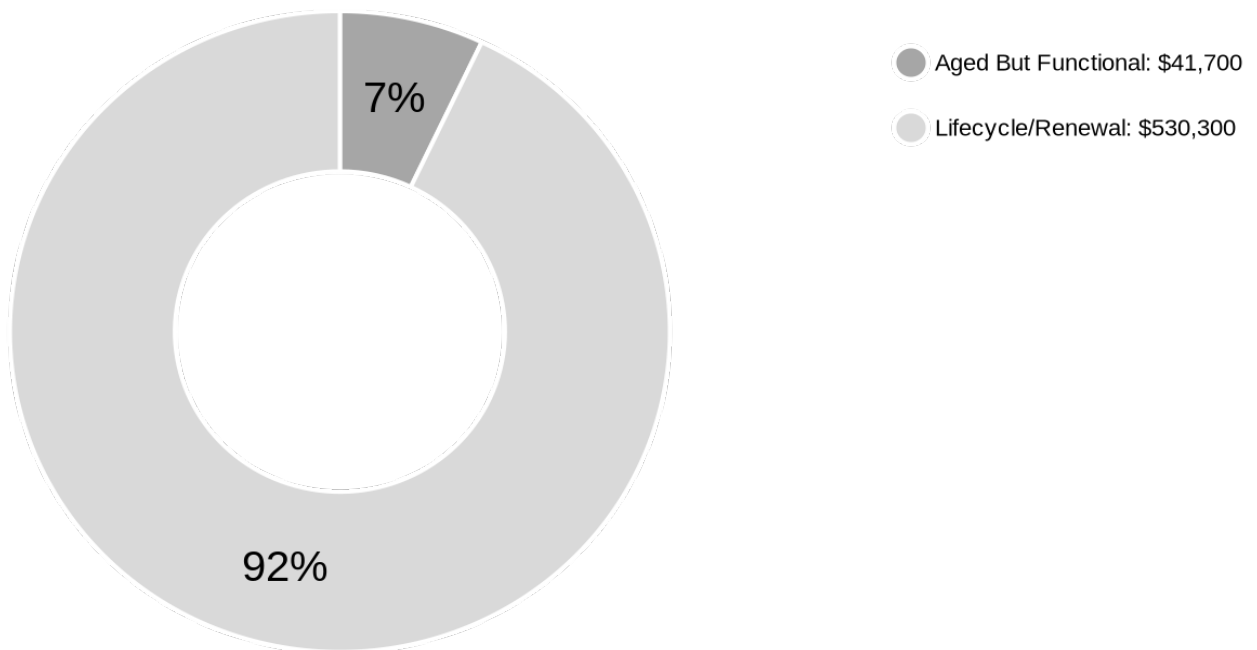
Plan Type Descriptions & Distribution

Safety	■	An observed or reported unsafe condition that if left unaddressed could result in injury; a system or component that presents potential liability risk.
Performance/Integrity	■	Component or system has failed, is almost failing, performs unreliably, does not perform as intended, and/or poses risk to overall system stability.
Accessibility	■	Does not meet ADA, UFAS, and/or other accessibility requirements.
Environmental	■	Improvements to air or water quality, including removal of hazardous materials from the building or site.
Retrofit/Adaptation	■	Components, systems, or spaces recommended for upgrades in order to meet current standards, facility usage, or client/occupant needs.
Aged But Functional	■	Any component or system that has aged past its industry-average expected useful life (EUL) but is not currently deficient or problematic.
Lifecycle/Renewal	■	Any component or system that is neither deficient nor aged past EUL but for which future replacement or repair is anticipated and budgeted.

10-Year Total: \$571,900

Each line item in the cost database is assigned a Plan Type, which is the primary reason or rationale for the recommended replacement, repair, or other corrective action. This is the “why” part of the equation. A cost or line item may commonly have more than one applicable Plan Type; however, only one Plan Type will be assigned based on the “best” fit, typically the one with the greatest significance and highest on the list below.
